North Rocks Park Precinct Masterplan

North Rocks Park Precinct Masterplan Preliminary Order of Costs

ENVIRONMENTAL INVESTIGATION SERVICES

CITY OF PARRAMATTA - NORTH ROCKS PARK

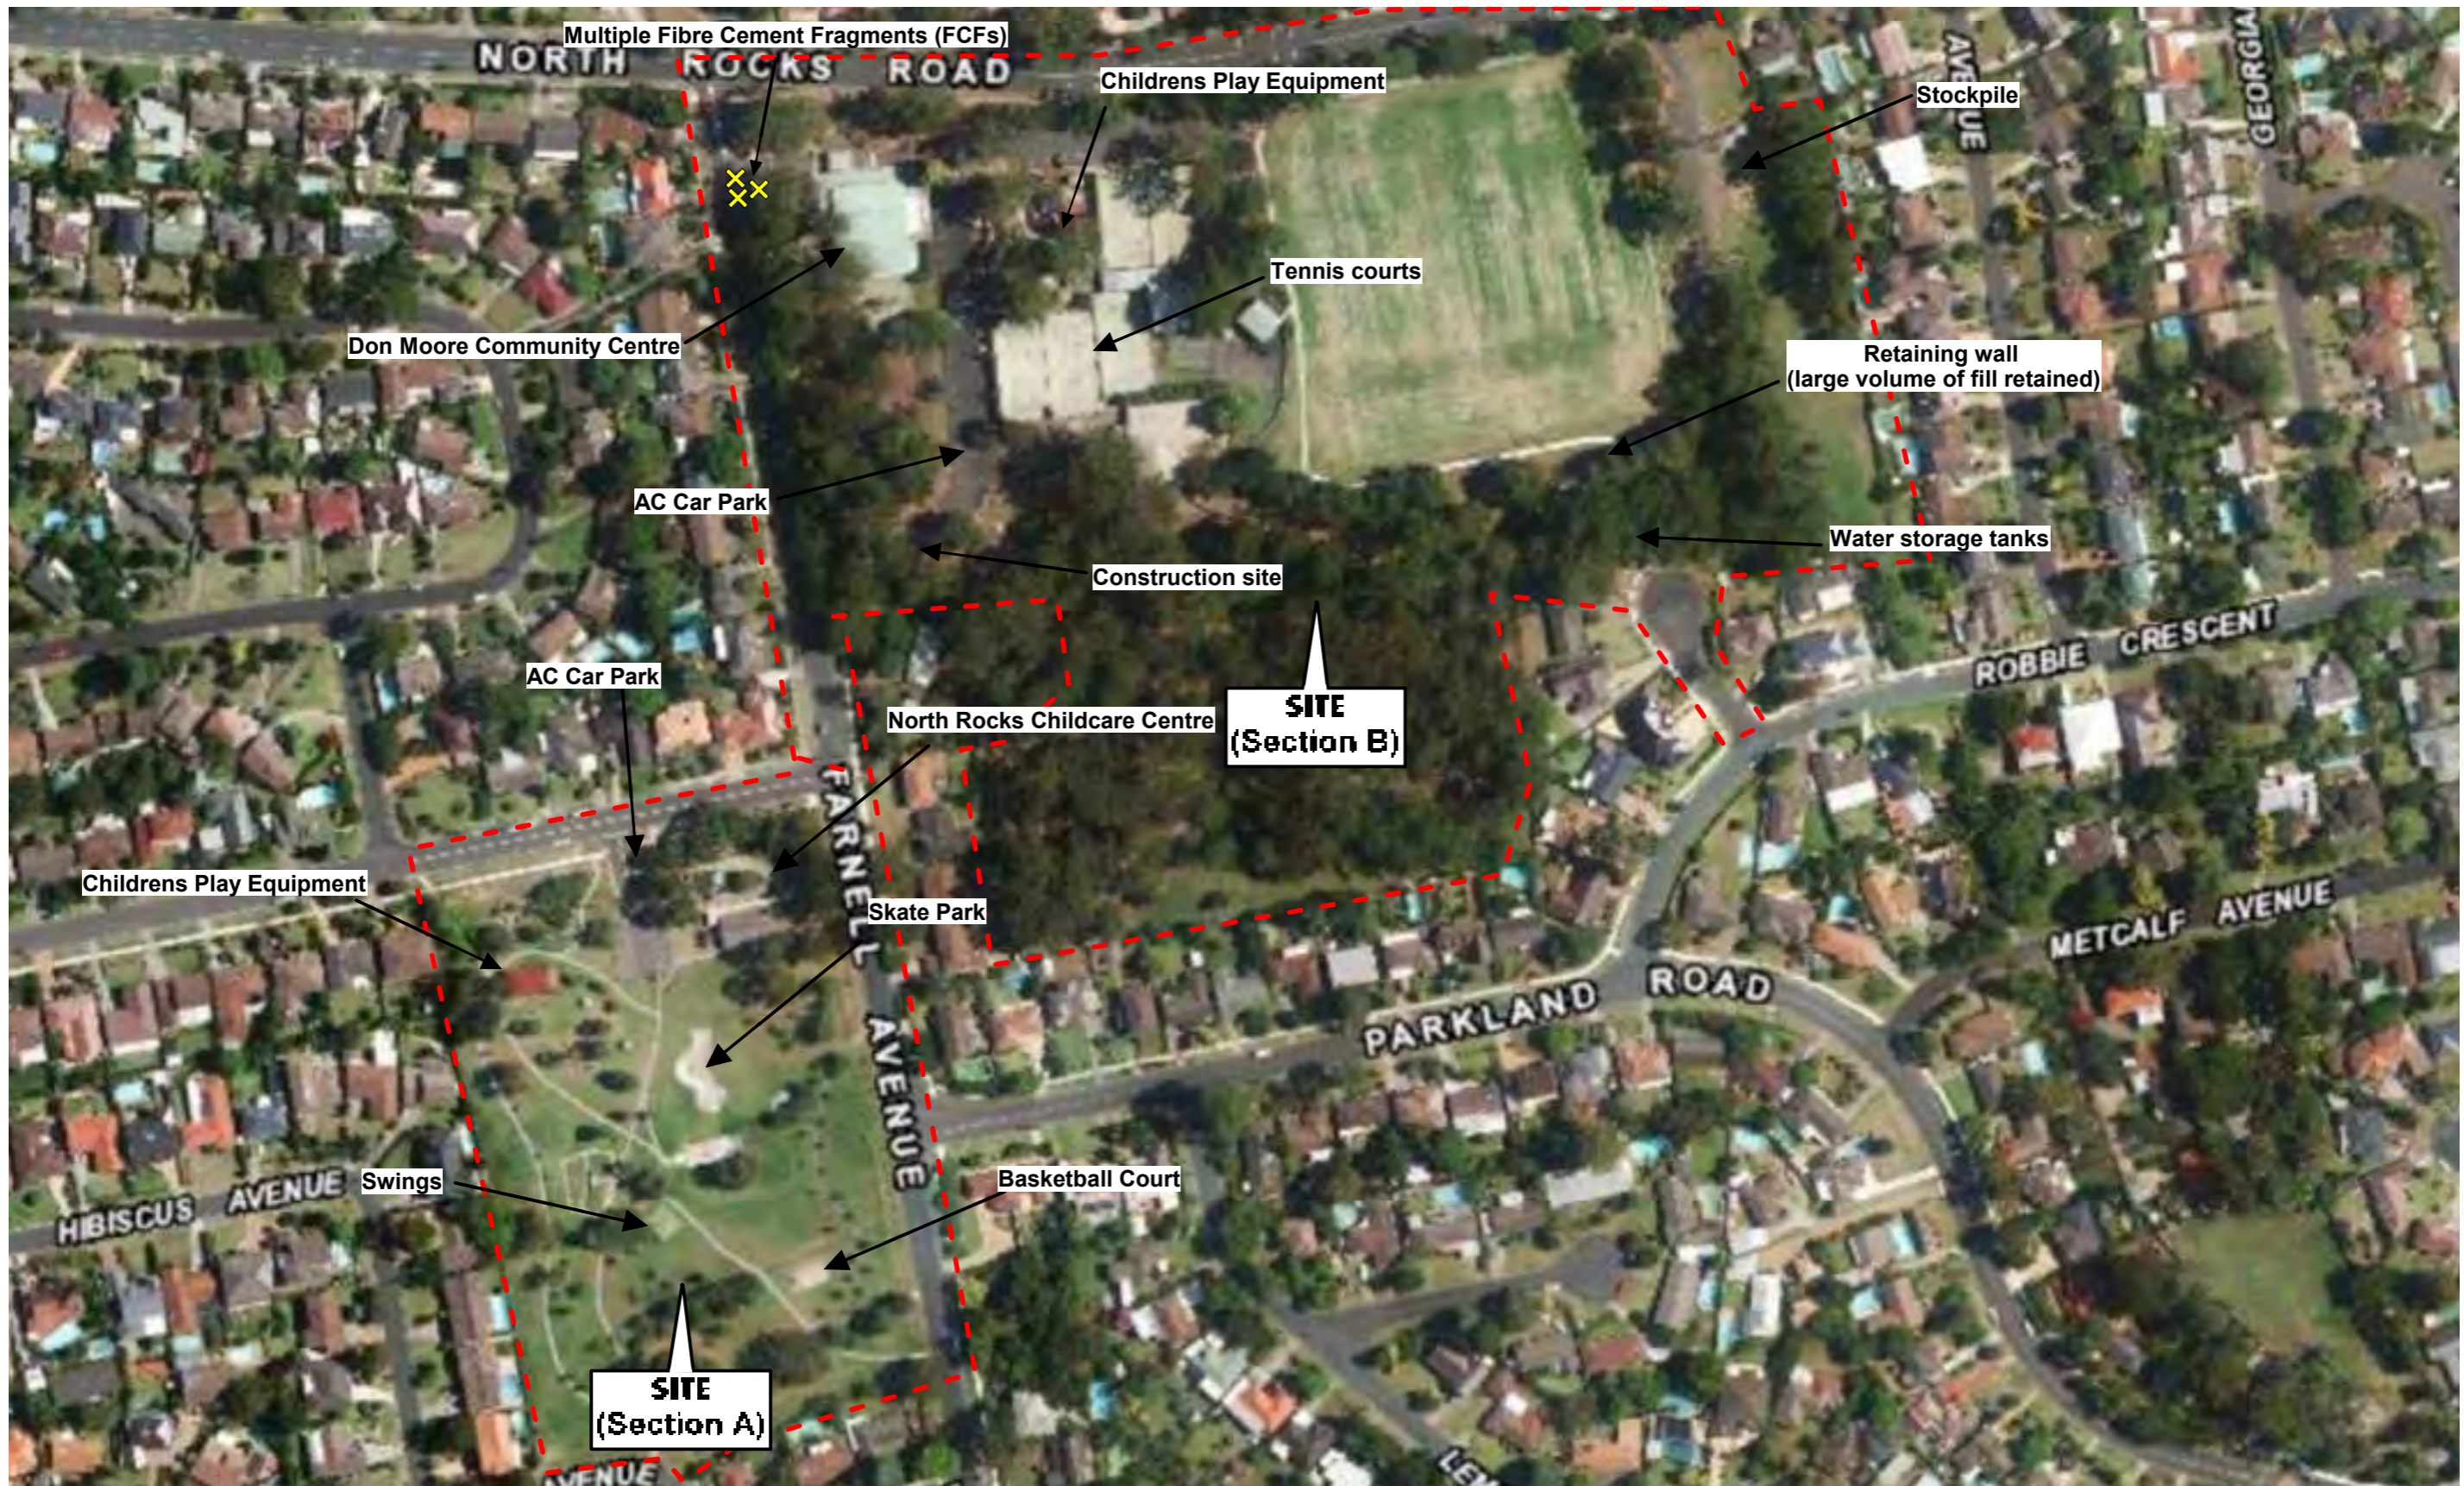
Multiple fragments of fibre cement (suspected of containing asbestos) were observed on the ground surface adjacent to the east of the community centre (see Figure 2). No other visible or olfactory indicators of contamination were observed.

Multiple Fibre Cement Fragments (FCFs)

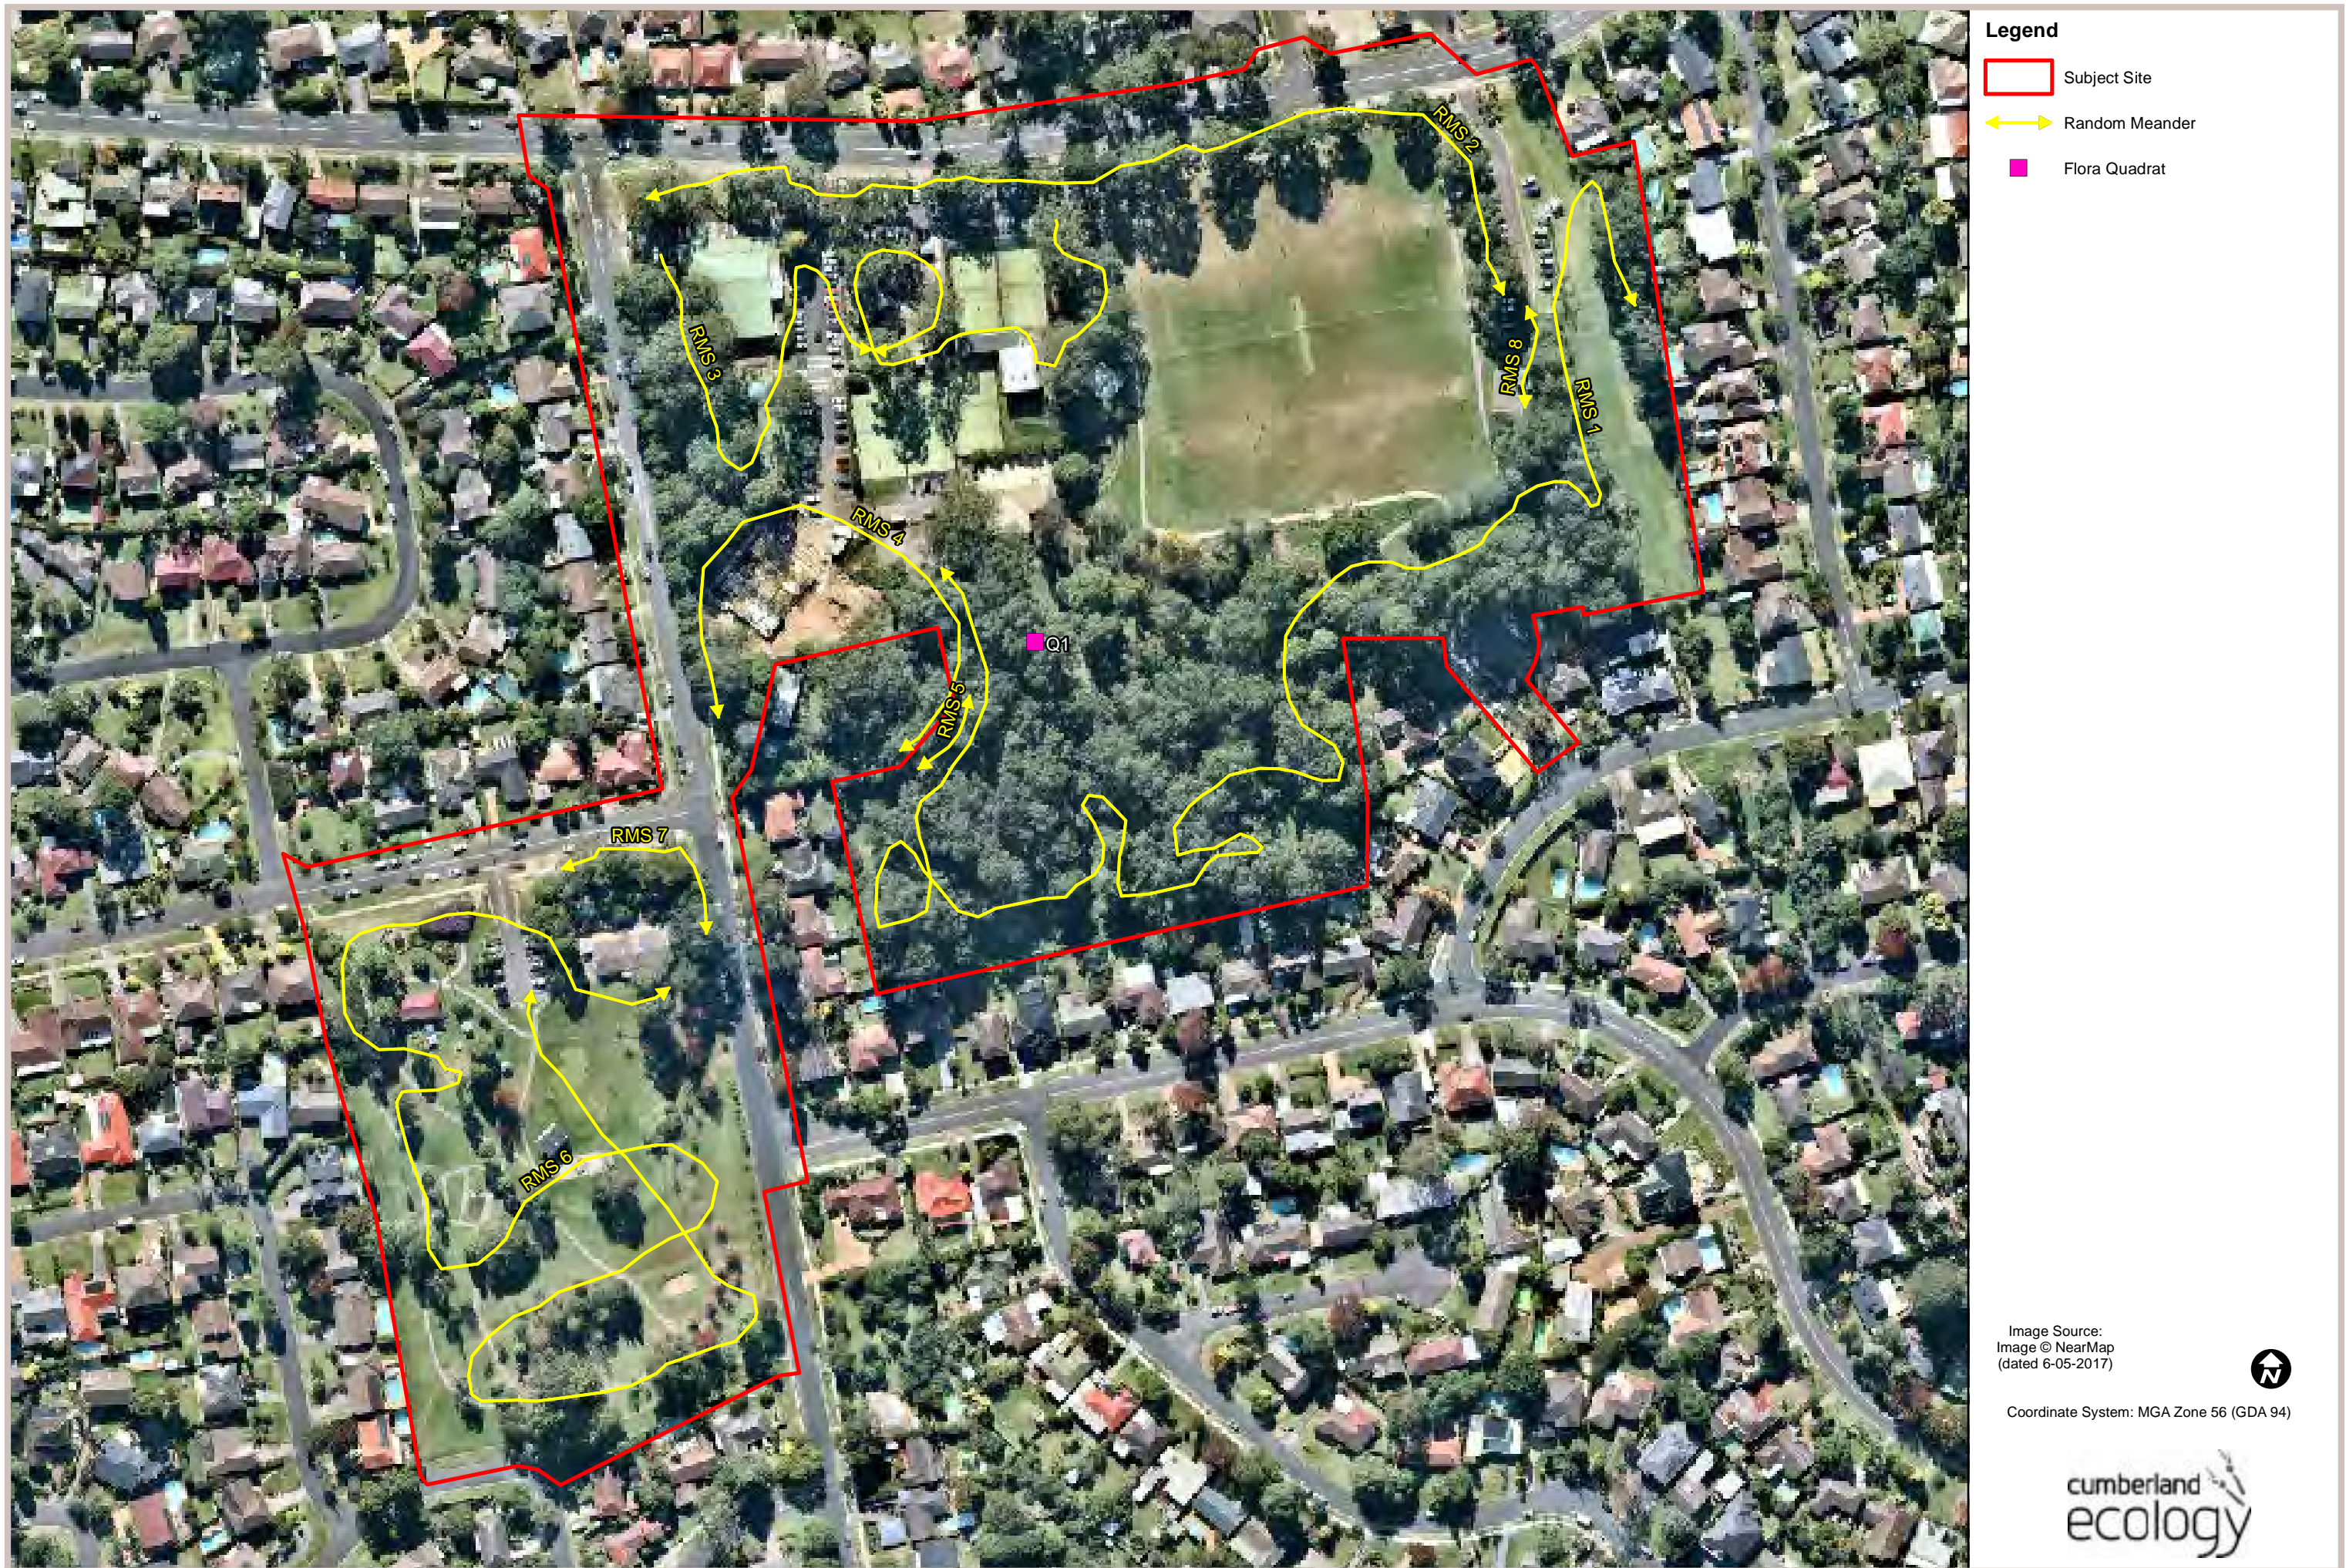
- Legend**
- Subject Site
 - ↔ Random Meander
 - Flora Quadrat

Figure 2.1. Flora Survey Locations

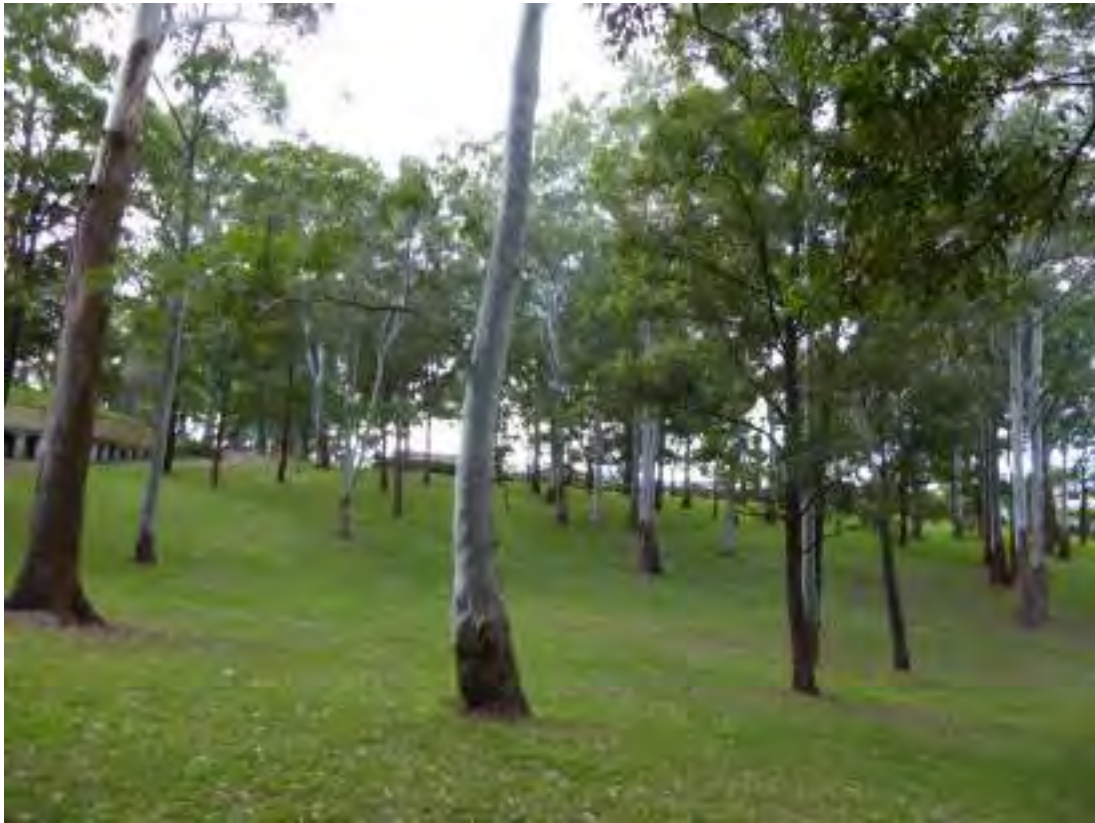
Photograph 3.1 Large patch BGHF in the south of North Rocks Park

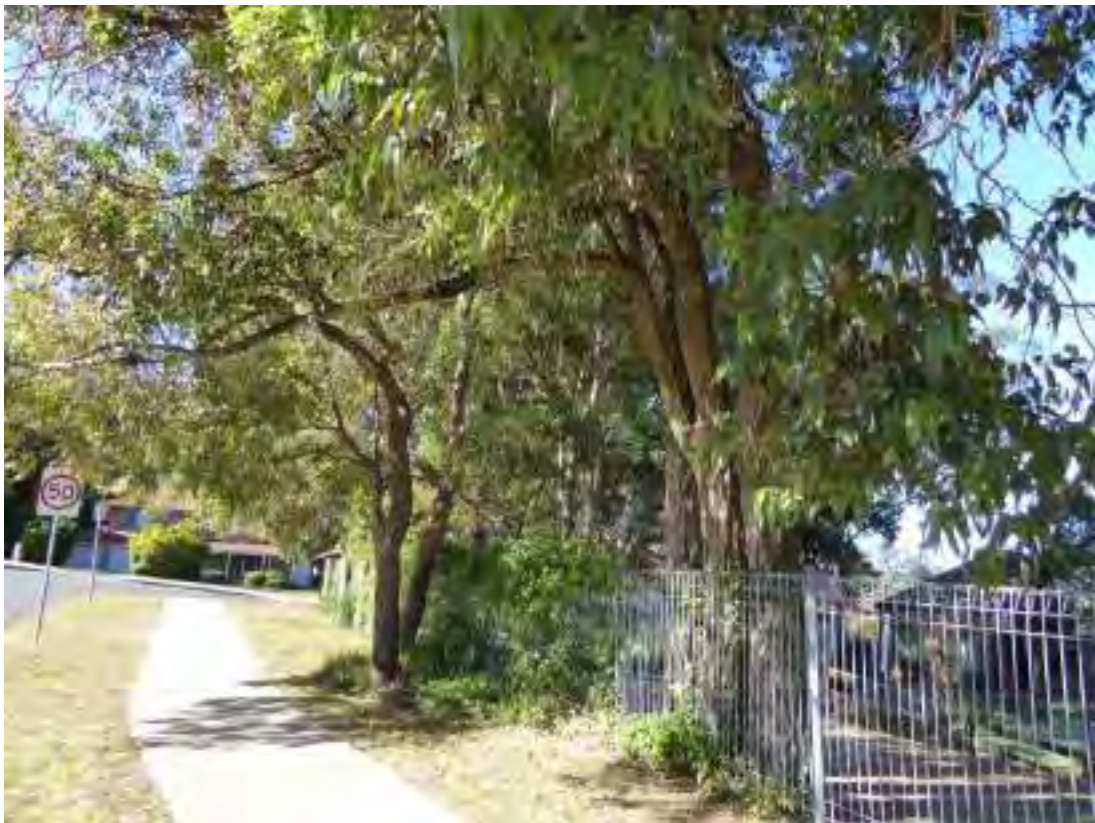
Photograph 3.2 BGHF in north-east of John Wearn Reserve

There are several *Eucalyptus pilularis* trees planted in John Wearn Reserve outside of the BGHF patch in the north-east. A review of historical aerial photography shows that in 1943 (**Figure 3.2**) this area was entirely cultivated and these trees are unlikely to be remnant or natural regrowth of BGHF. The trees have been mapped as Urban Exotic/Native as described in **Section 3.1.ii** below. The current BGHF patch in the north-east however is in the proximate location of trees present on a roadside in 1943 which are likely to have provided propagules for regrowth of the extant patch, and the several large trees in this area may be remnant.

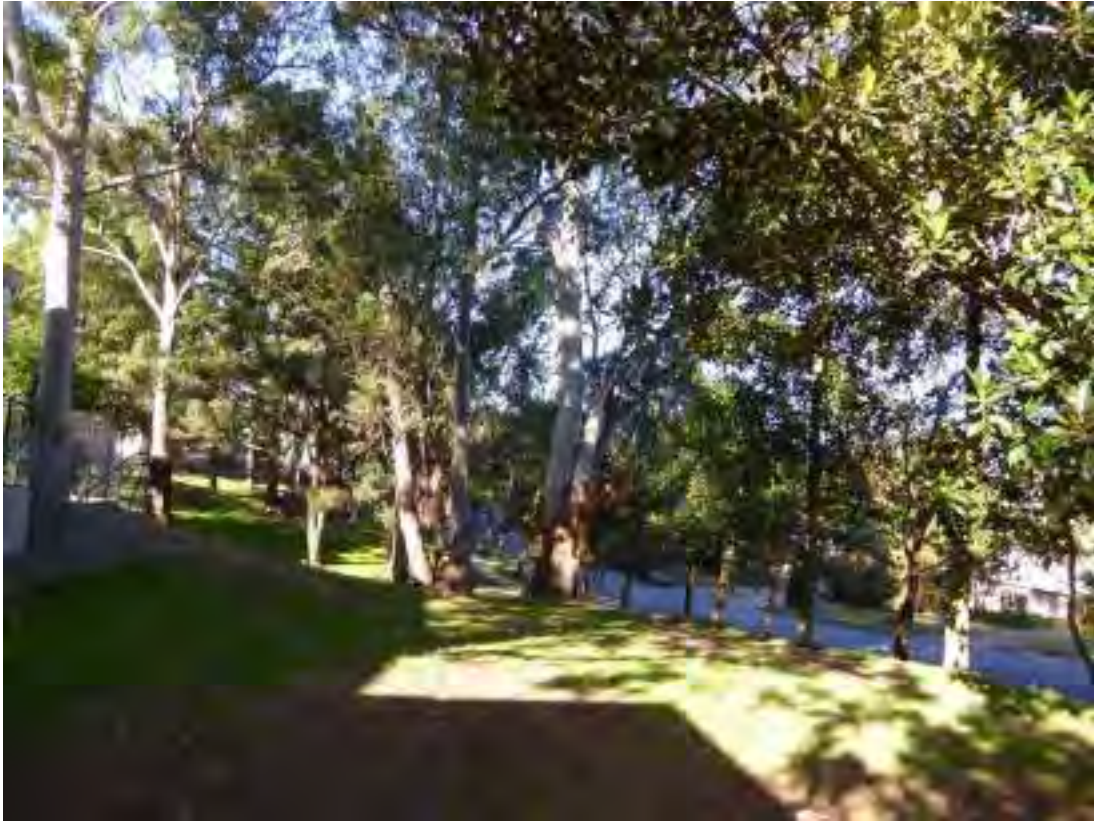
Photograph 3.3 Strip of BGHF in west of North Rocks Park

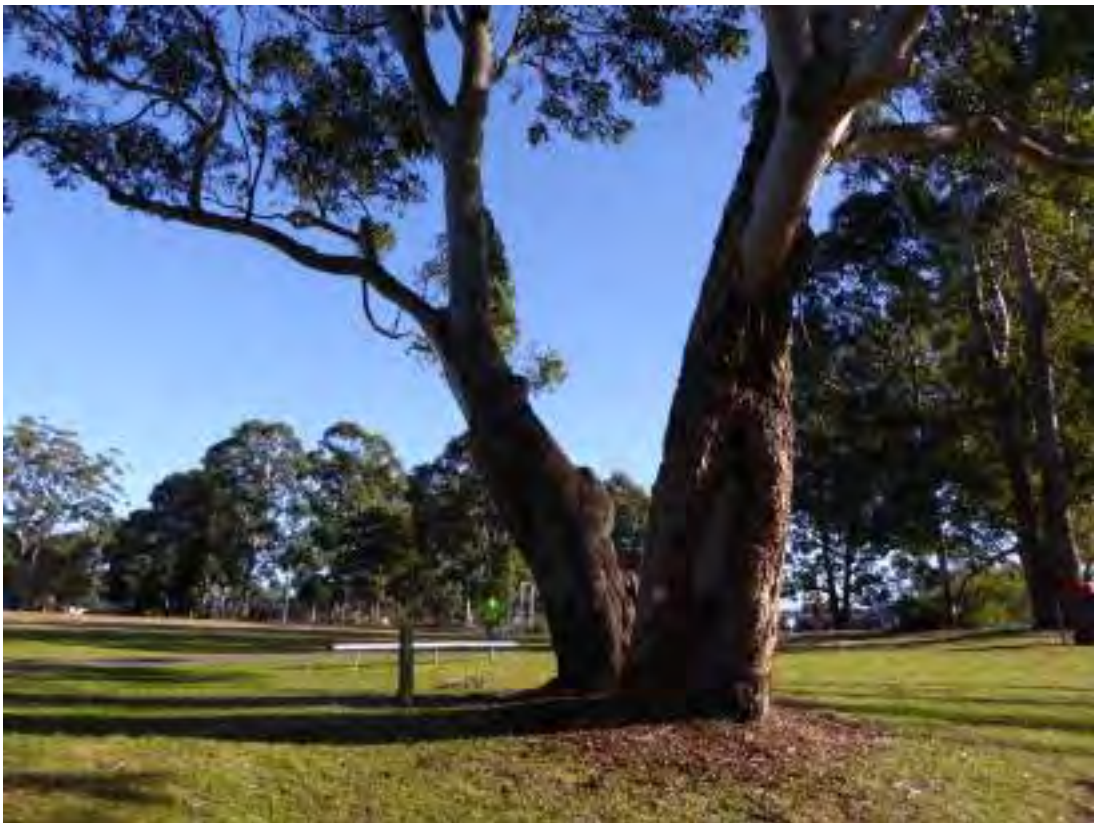
Photograph 3.4 BGHF canopy over exotic grassland within North Rocks Park

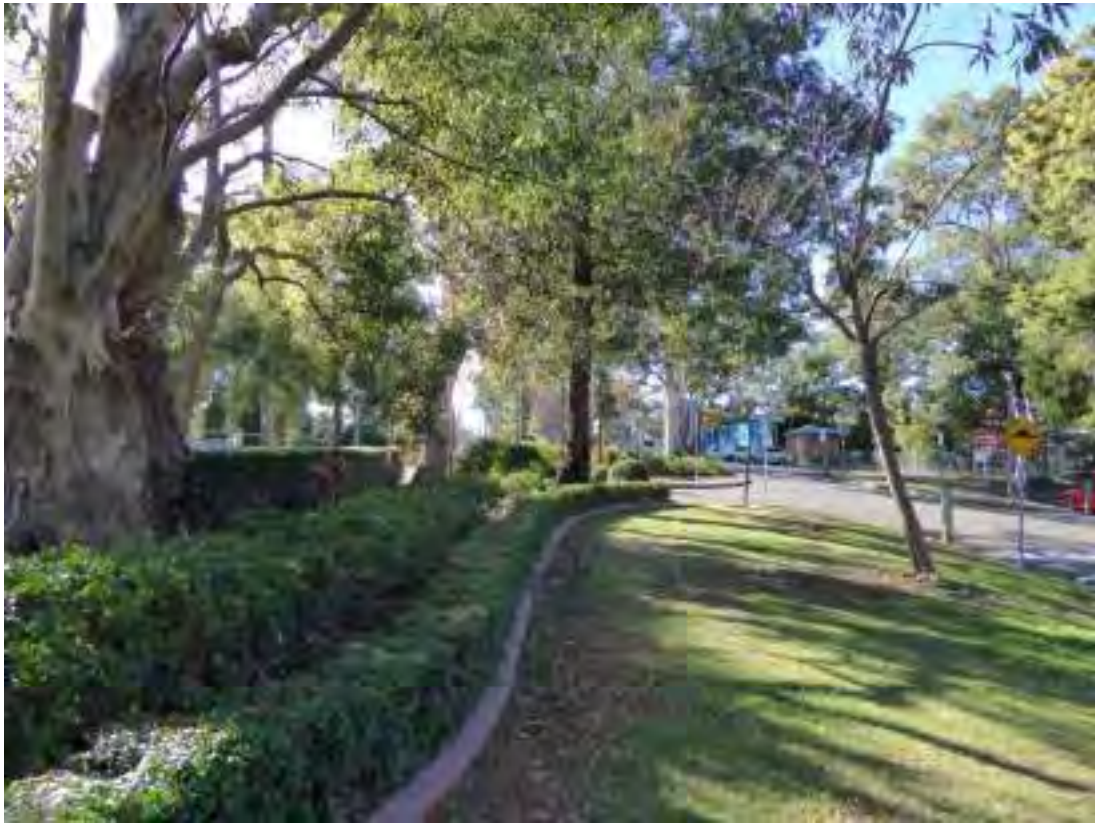
Photograph 3.5 BGHF in gardens along north of North Rocks Park

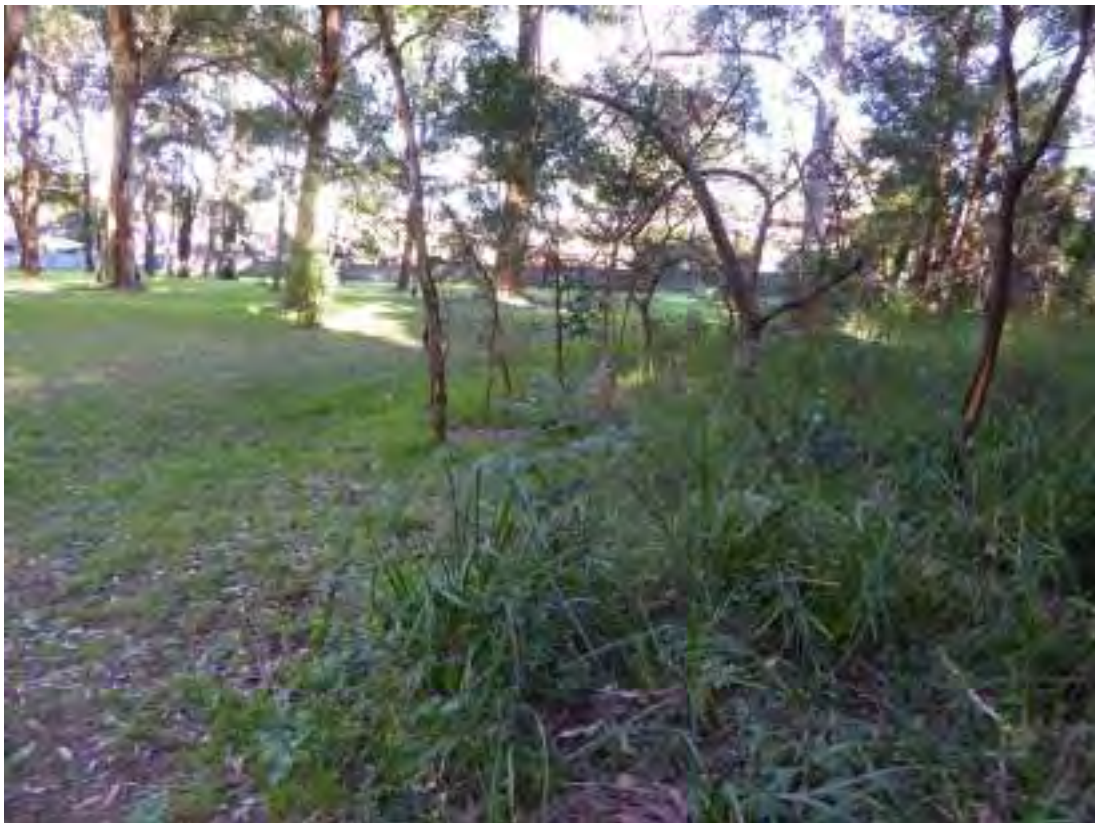
Photograph 3.6 BGHF with unmown ground layer and persisting shrubs

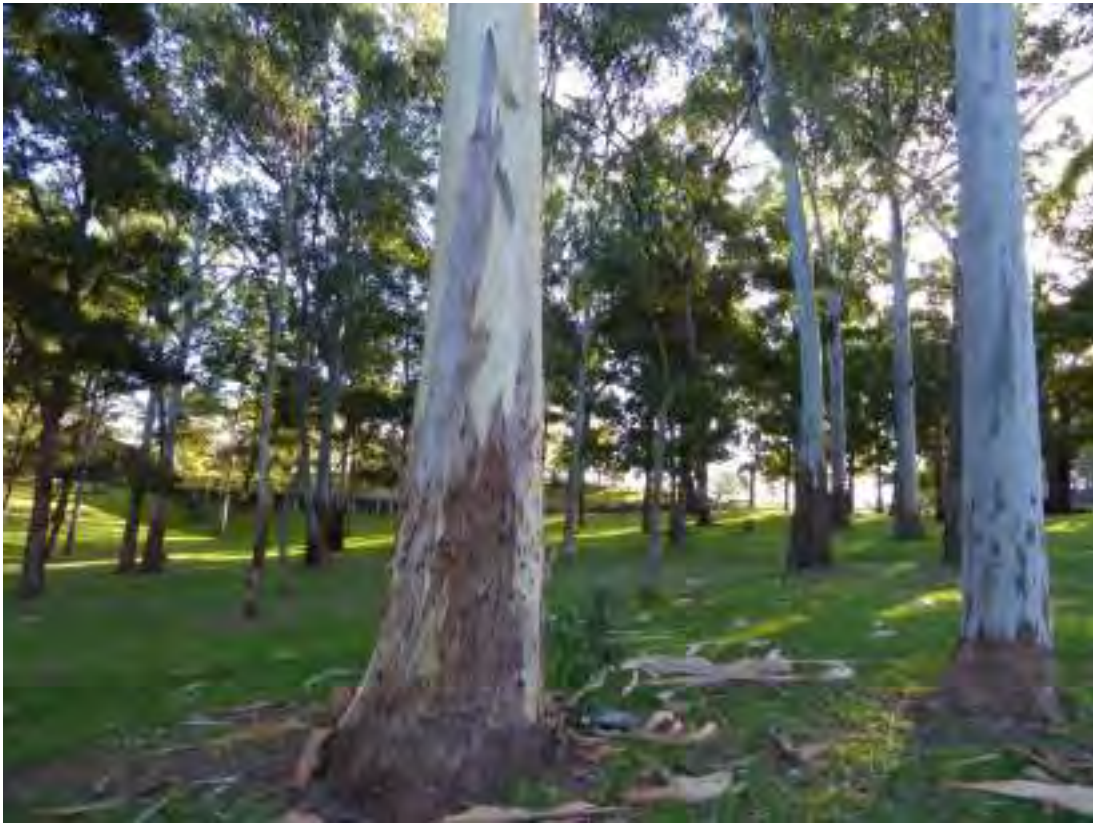
Photograph 3.7 Planted *Eucalyptus deanei* on edge of a large patch of BGHF

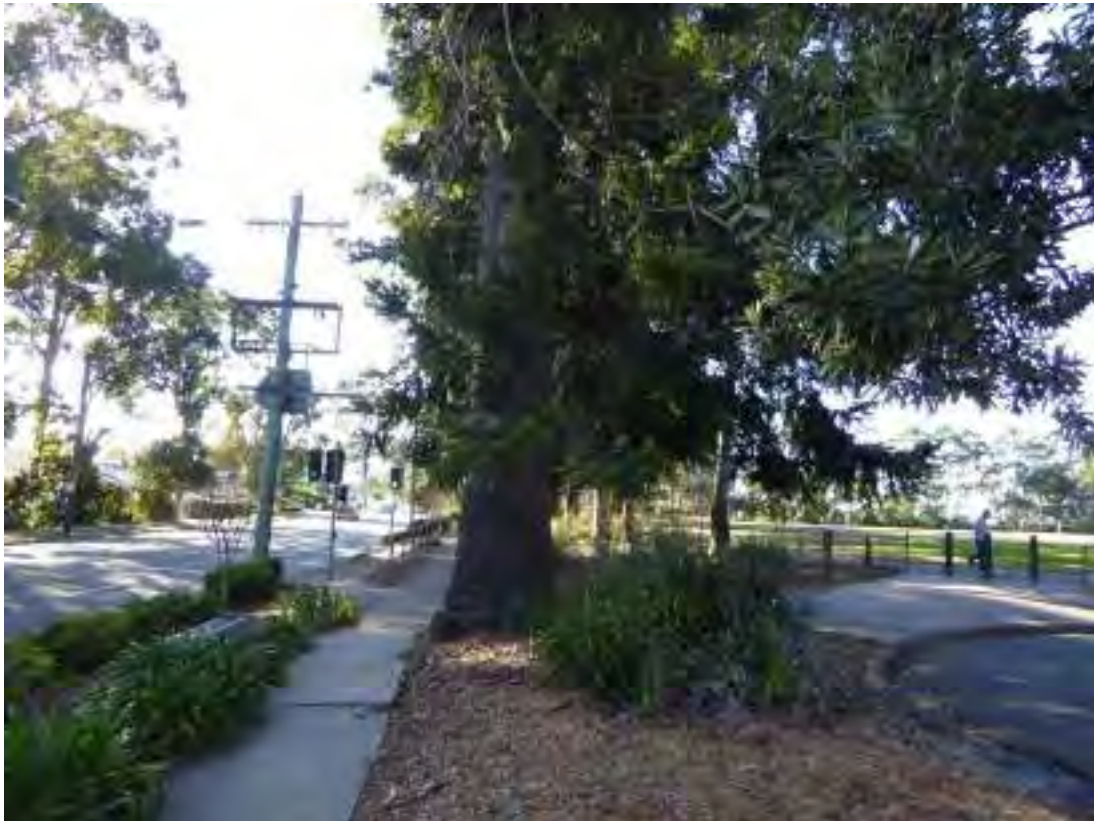
Photograph 3.8 Urban Exotic/Native Vegetation within North Rocks Park (north)

Ground layer species include planted natives such as *Lomandra longifolia*, *Doryanthes excelsa* (Gynea Lily), and exotics including both weeds and planted species such as *Hedychium gardnerianum* (Ginger Lily), *Tradescantia fluminensis* (Wandering Trad), and *Clivia miniata*.

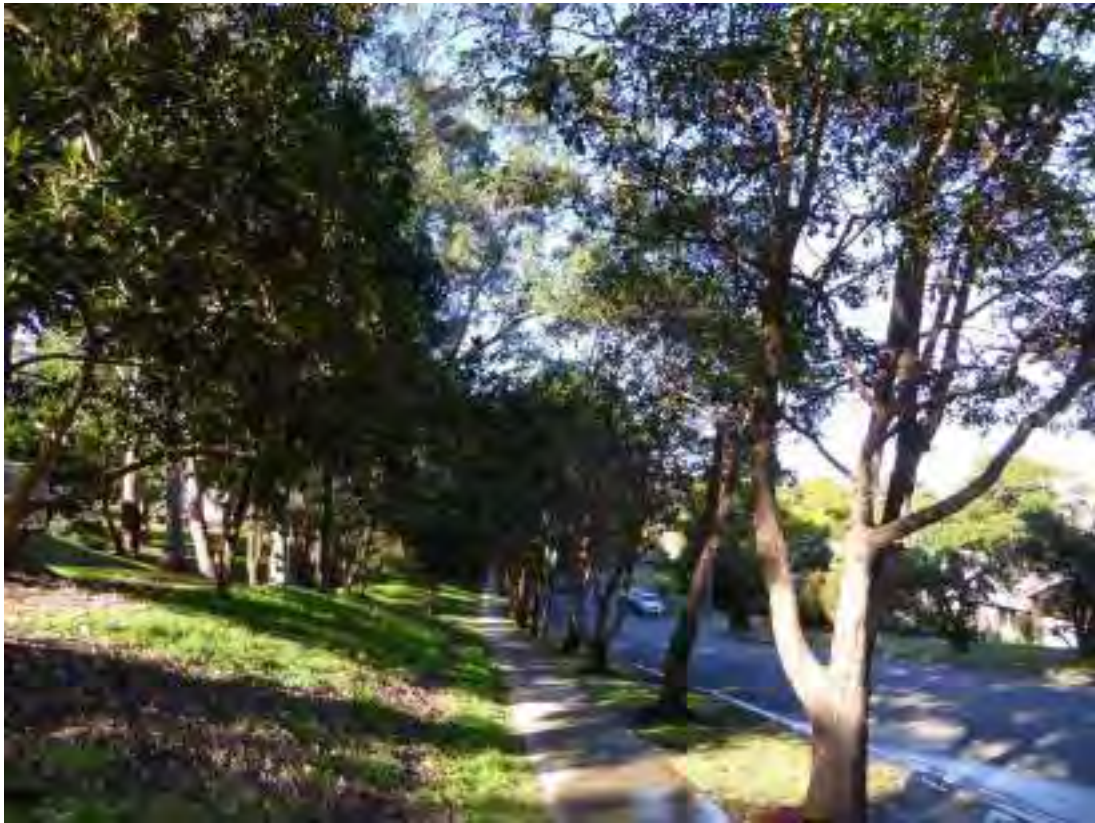
Photograph 3.9 Urban Exotic/Native Vegetation within North Rocks Park (west)

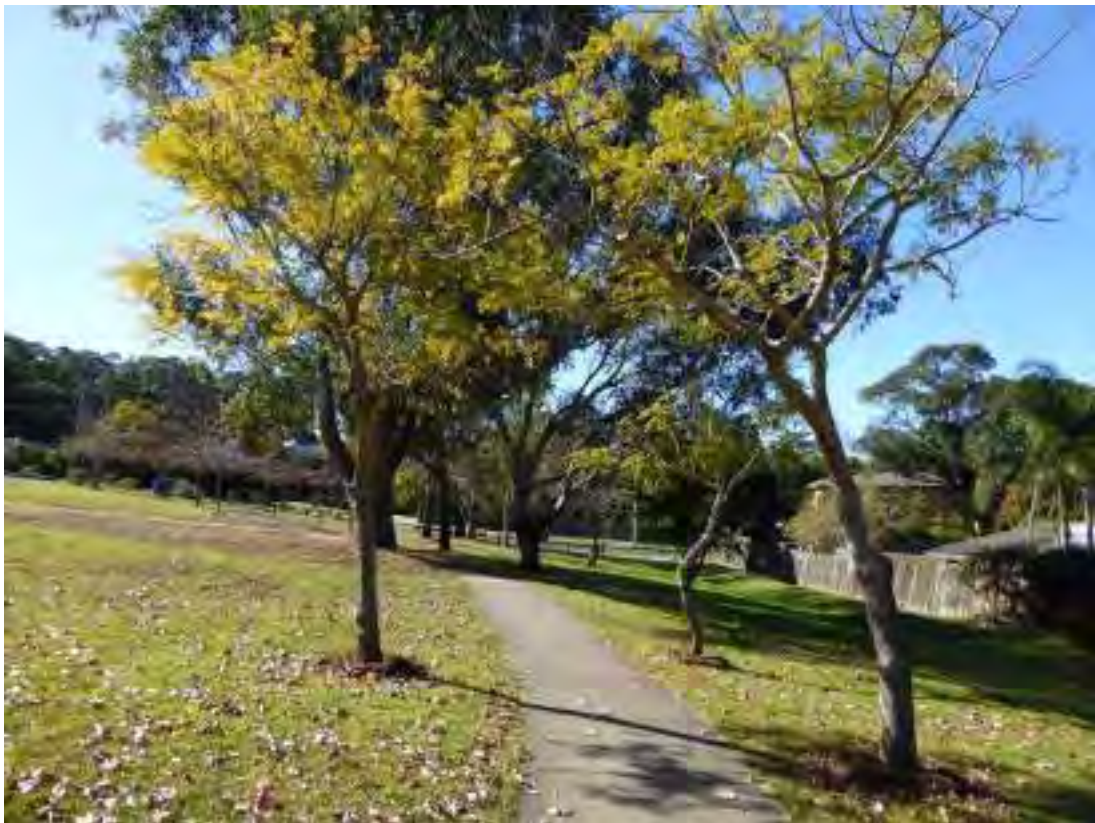
Photograph 3.10 Urban Exotic/Native Vegetation in John Wearn Reserve (south)

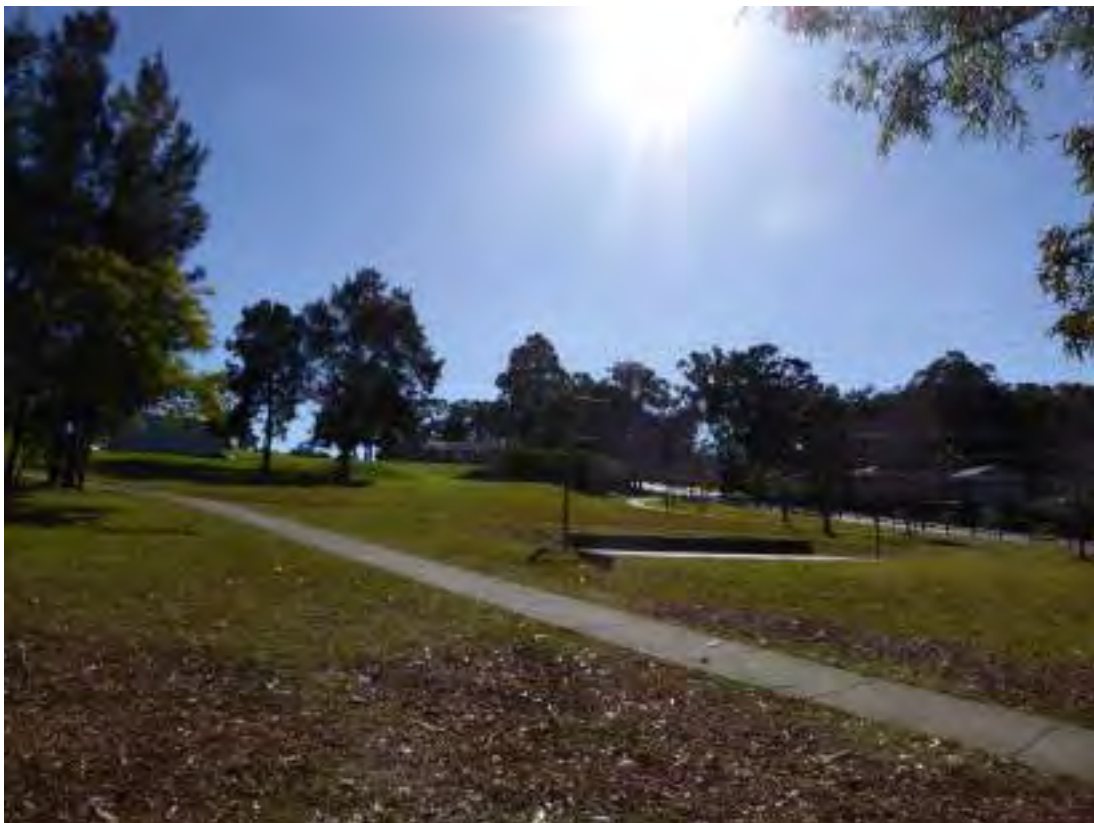
Large areas of the Subject Site consist of mown areas of exotic grasses, along with exotic lawn weeds (**Photograph 3.11**). Very few native species persist with individuals limited to very scattered isolated occurrences of common forbs such as *Cyperus gracilis* and grasses such as *Microlaena stipoides*. Exotic grasses present include the species *Cenchrus clandestinus* (Kikuyu), *Cynodon dactylon* (Couch), *Stenotaphrum secundatum* (Buffalo Grass). Lawn weeds include *Medicago polymorpha* (Burr-medic), *Plantago lanceolata* (Plant's Tongues), *Arctotheca calendula* (Capeweed), and *Paronychia brasiliensis* (Chilean Whitlow Wort).

Photograph 3.11 Exotic Dominated Grassland (John Wearn Park)

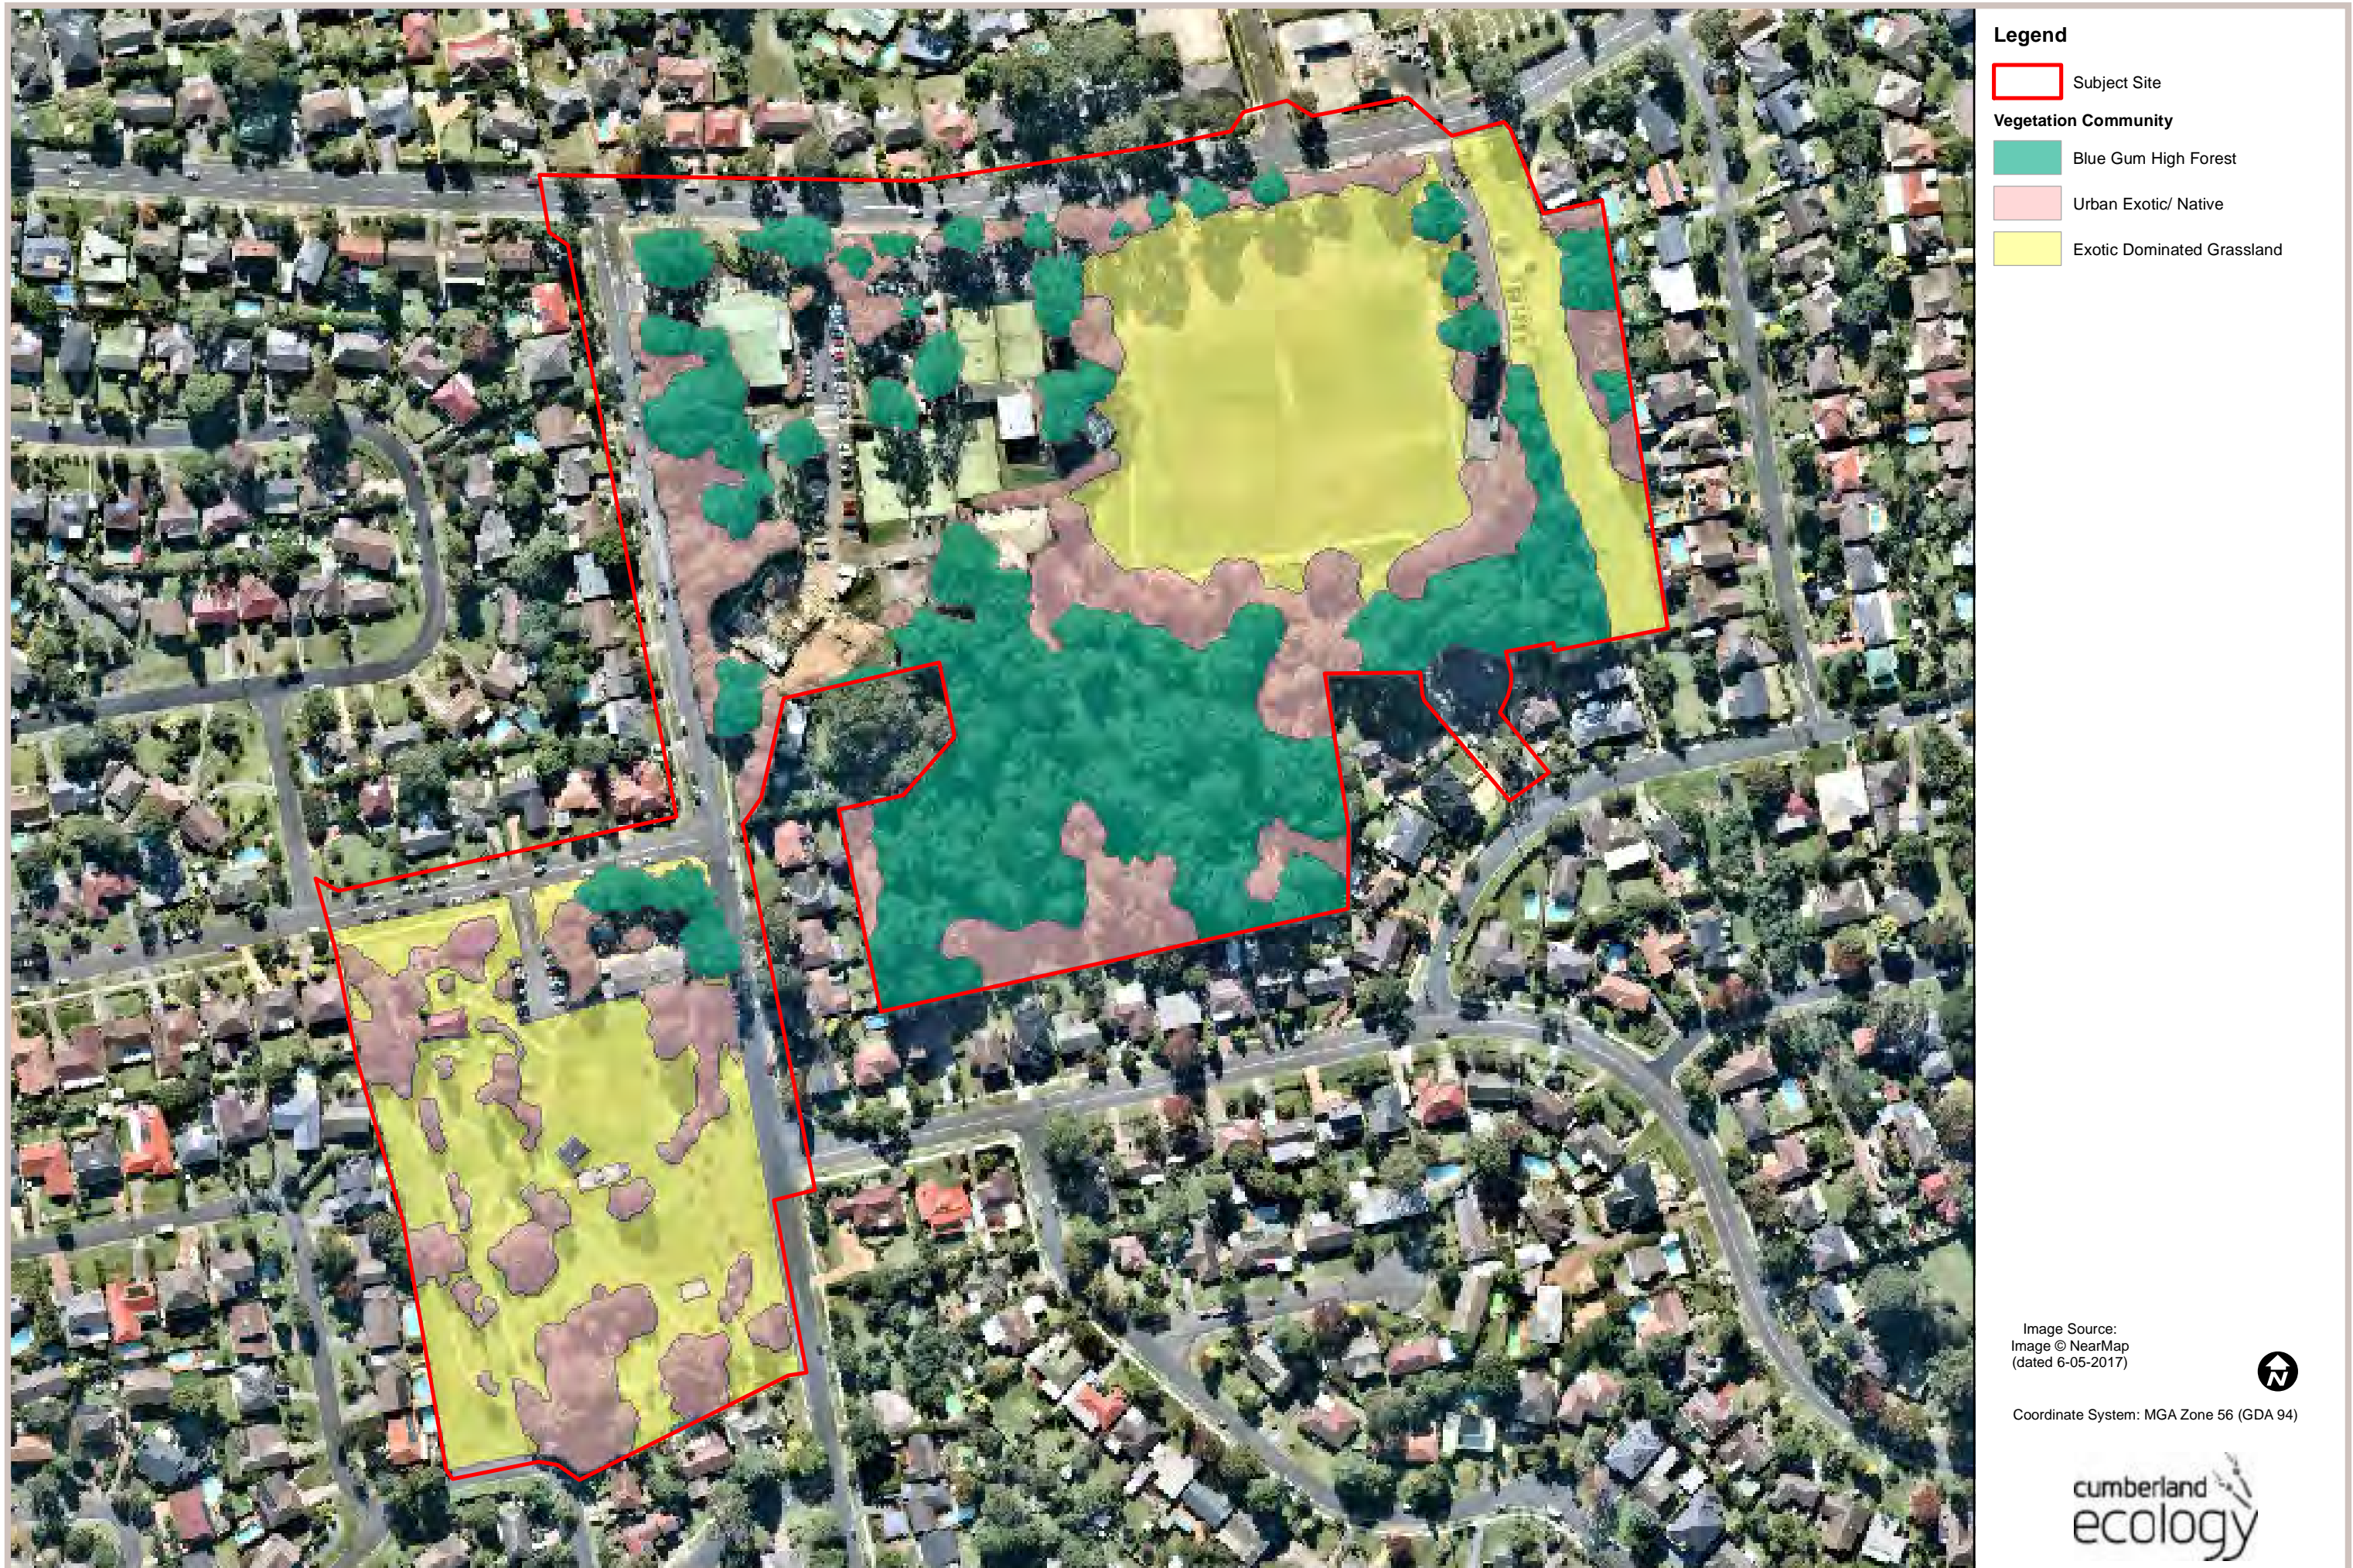
Figure 3.1. Vegetation Communities within the Subject Site
