DETAILED MAPPING OF THE DUCK RIVER CATCHMENT

Prepared for Parramatta City Council

Project Title	DUCK RIVER CATCHMENT WATERWAYS MAINTENANCE AND REHABILITATION MASTER PLAN
Document Title	PRELIMINARY ASSESSMENT OF THE DUCK RIVER CATCHMENT WATERWAYS
Client	Parramatta City Council
Client contact	Pino Todarello

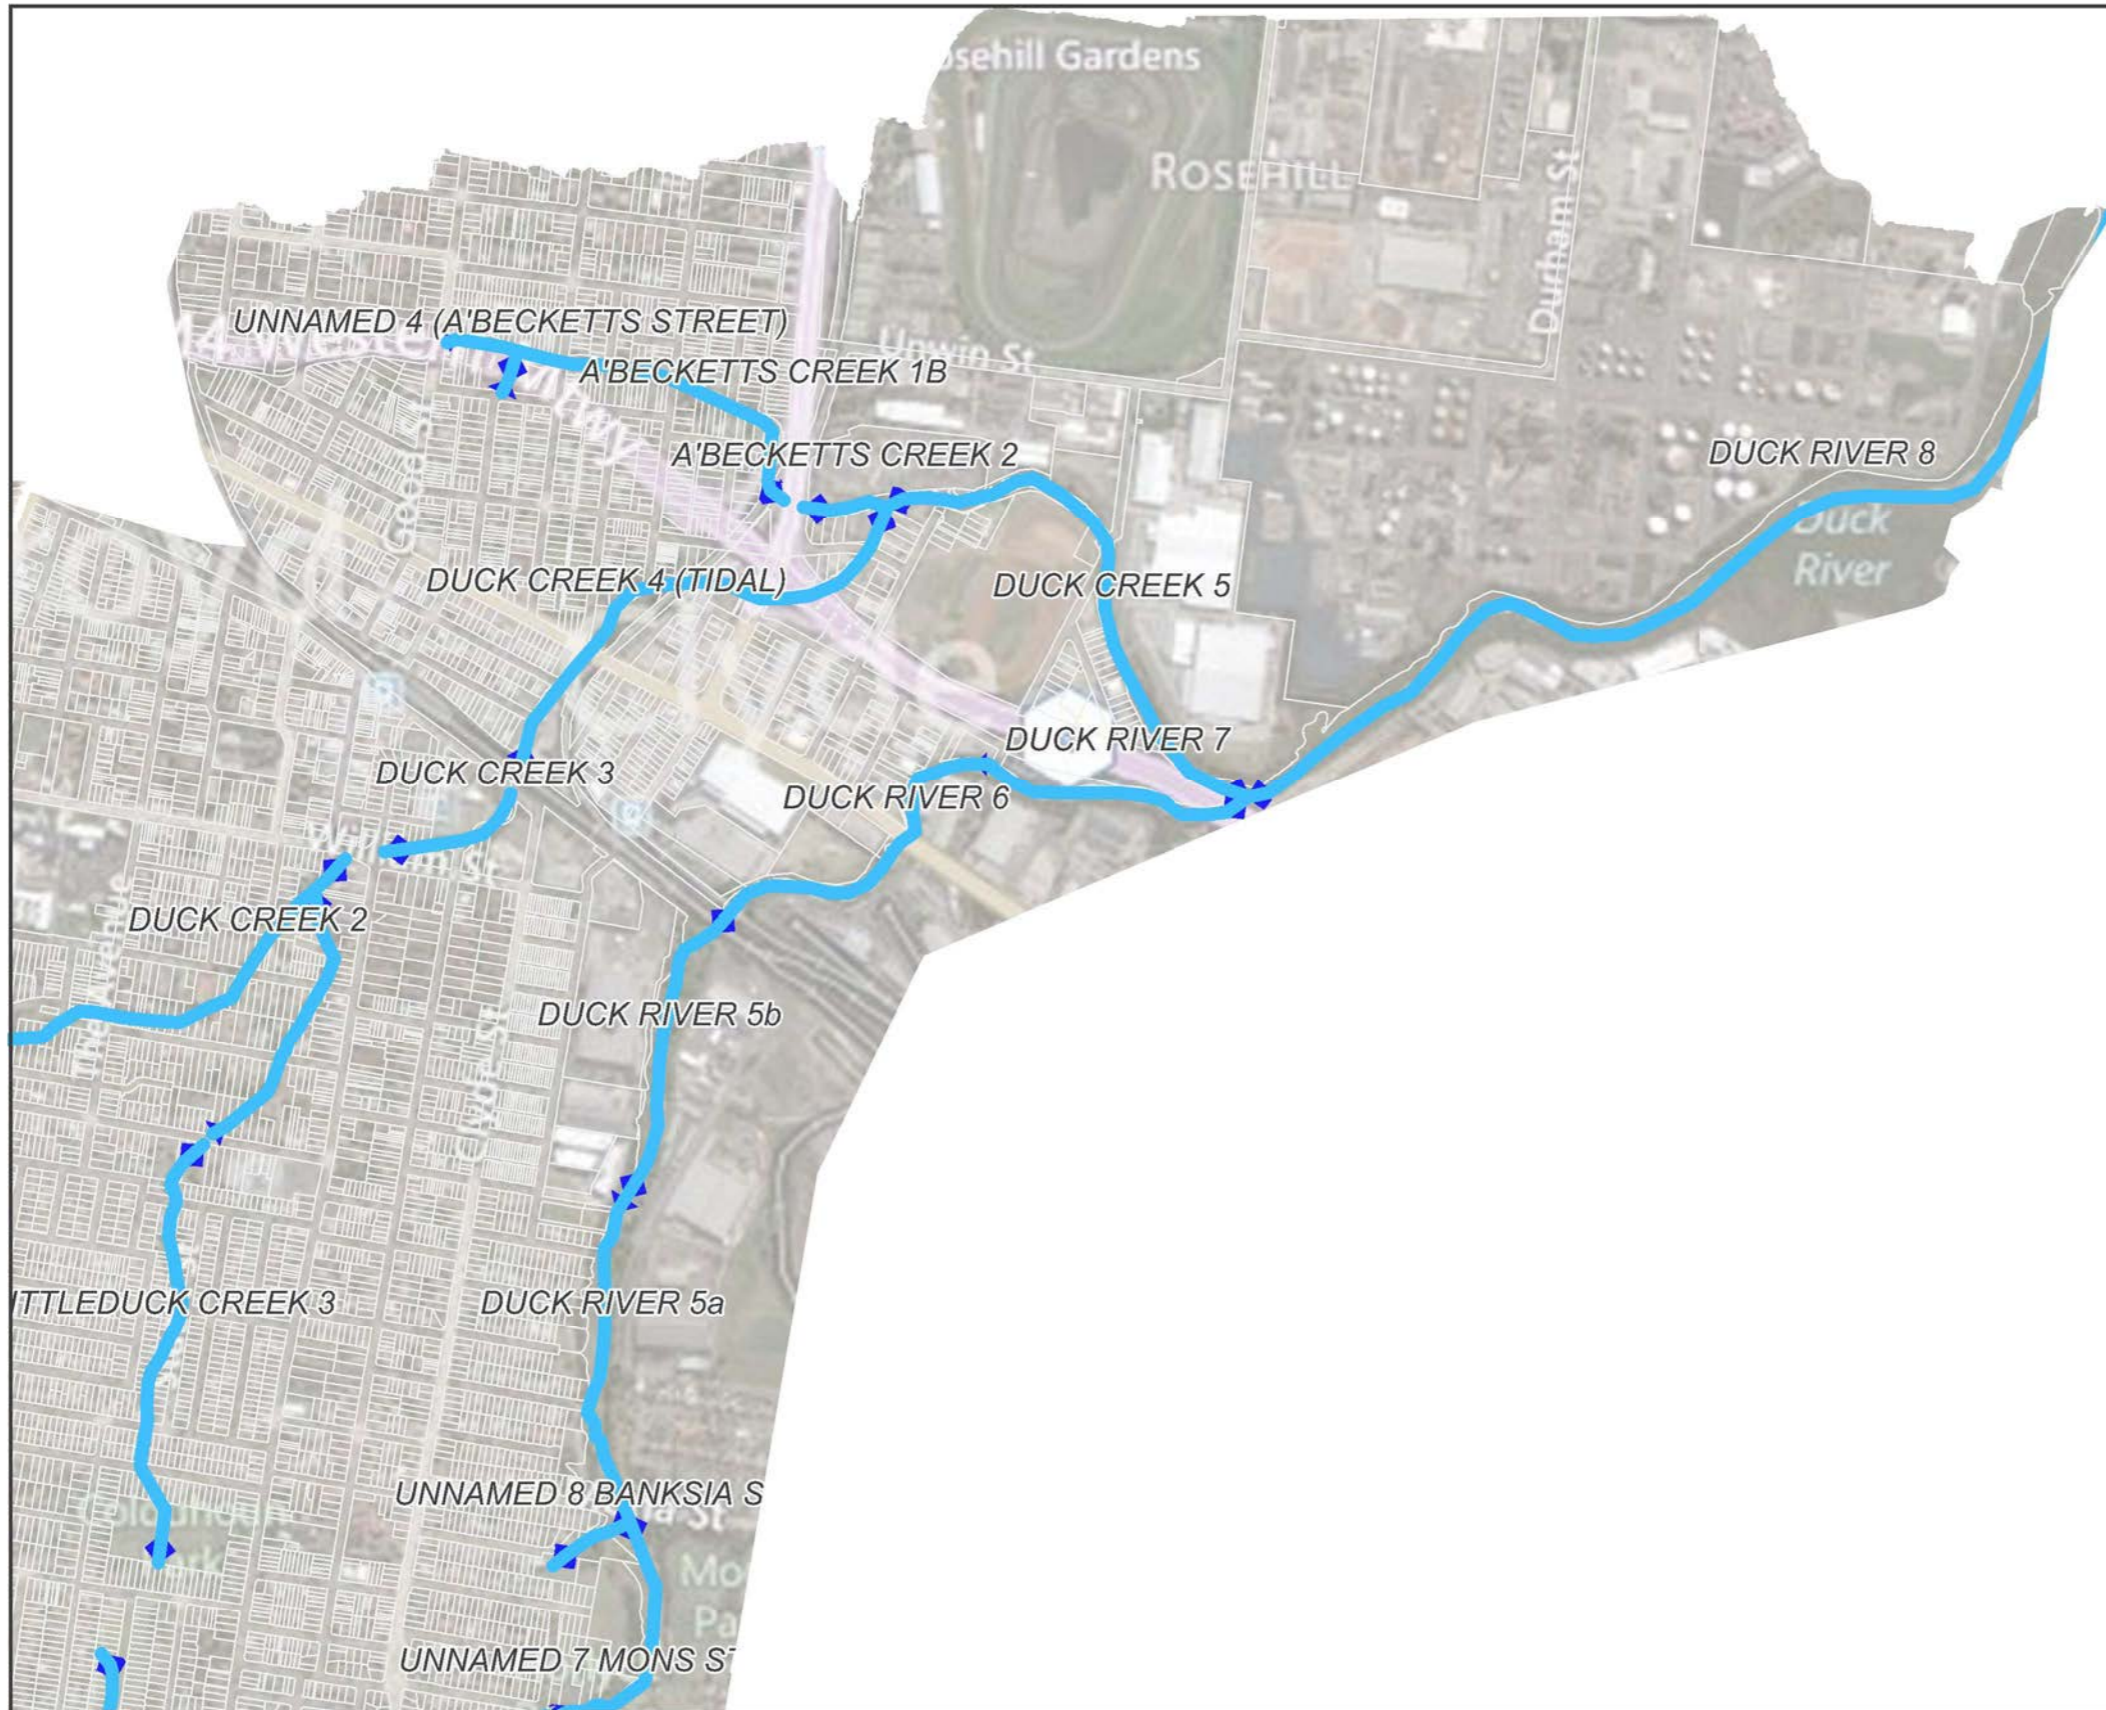
file: overviewMP Map 1
date: 17/05/2012

REACH OVERVIEW DUCK RIVER CATCHMENT PARRAMATTA LGA

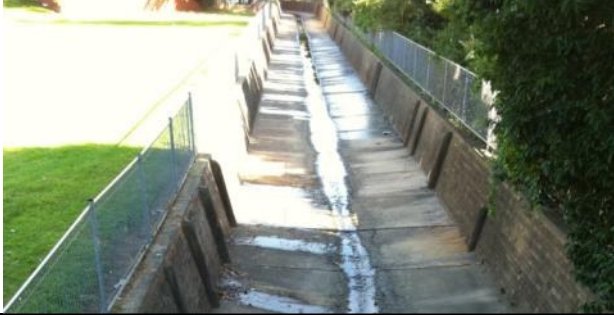
Table 1. Channel form and condition – criteria for allocation and examples

CHANNEL CONDITION	EXAMPLE	CHANNEL CONDITION	EXAMPLE
Concrete Lined Example: Duck Creek 2 (pictured)

Stable: Few or no signs of bed and bank erosion, vegetated floodplain Example: Duck River Reach 4 (Pictured)

Highly Eroding: Stream is deeply incised, generally earth/rock lined with regular pinch points. Example: Smalls Creek (pictured)

Aggregating. Weirs or impoundments assist in trapping the movement of sediment leading to buildup Example: behind the 'stepping stones' weir (Pictured)

Moderately Eroding: Stream is incised and contained, regular bank undercutting and evidence of scour Example: Duck River bank erosion in Reach 1 (Pictured)	 	Tidal: Stream is under tidal influence Example Lower Duck River reaches 4-6

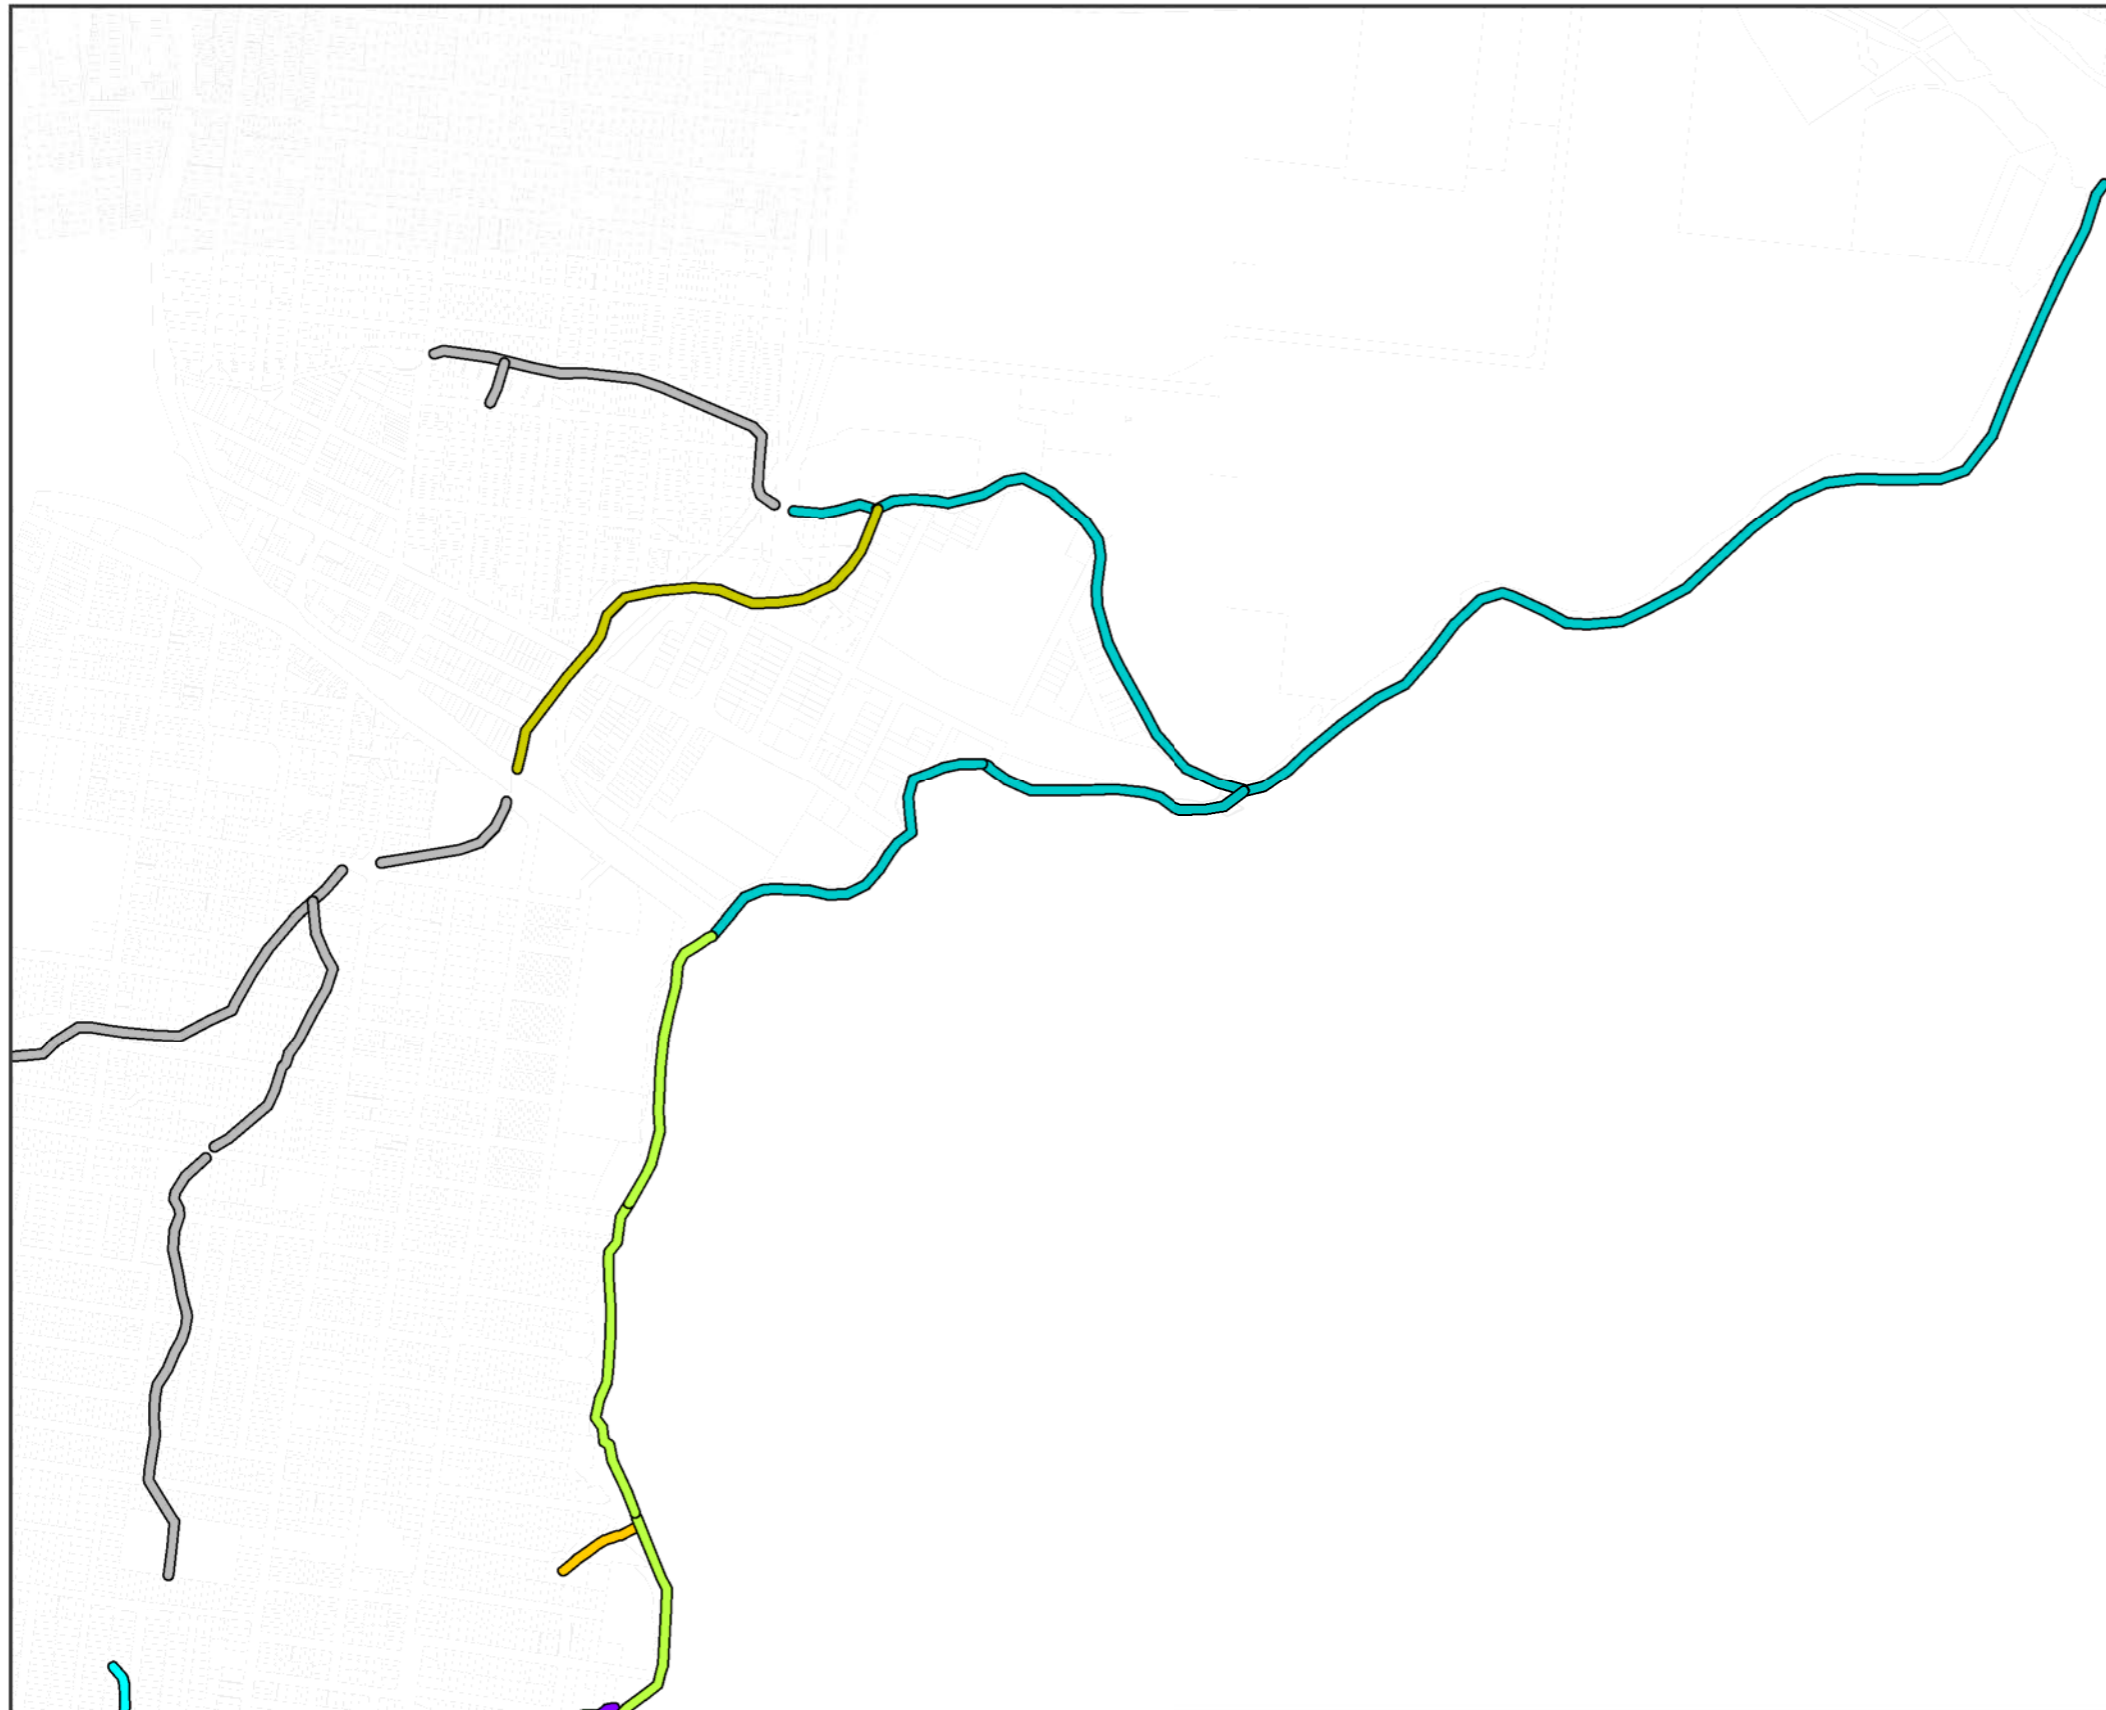
file: attributesMP Map 1
date: 17/05/2012

CHANNEL ATTRIBUTES DUCK RIVER CATCHMENT PARRAMATTA LGA

Concrete lined (managed by Sydney Water)	(10)
Highly eroding	(1)
Moderate/high erosion	(3)
Moderate/Highly Eroding	(1)
Moderately eroding	(3)
Stable	(10)
Stable/ moderately eroding	(3)
Stable/aggregating	(3)
Stable/Moderately eroding	(1)
Tidal/concrete	(1)
Tidal/mangrove/aggregating	(5)

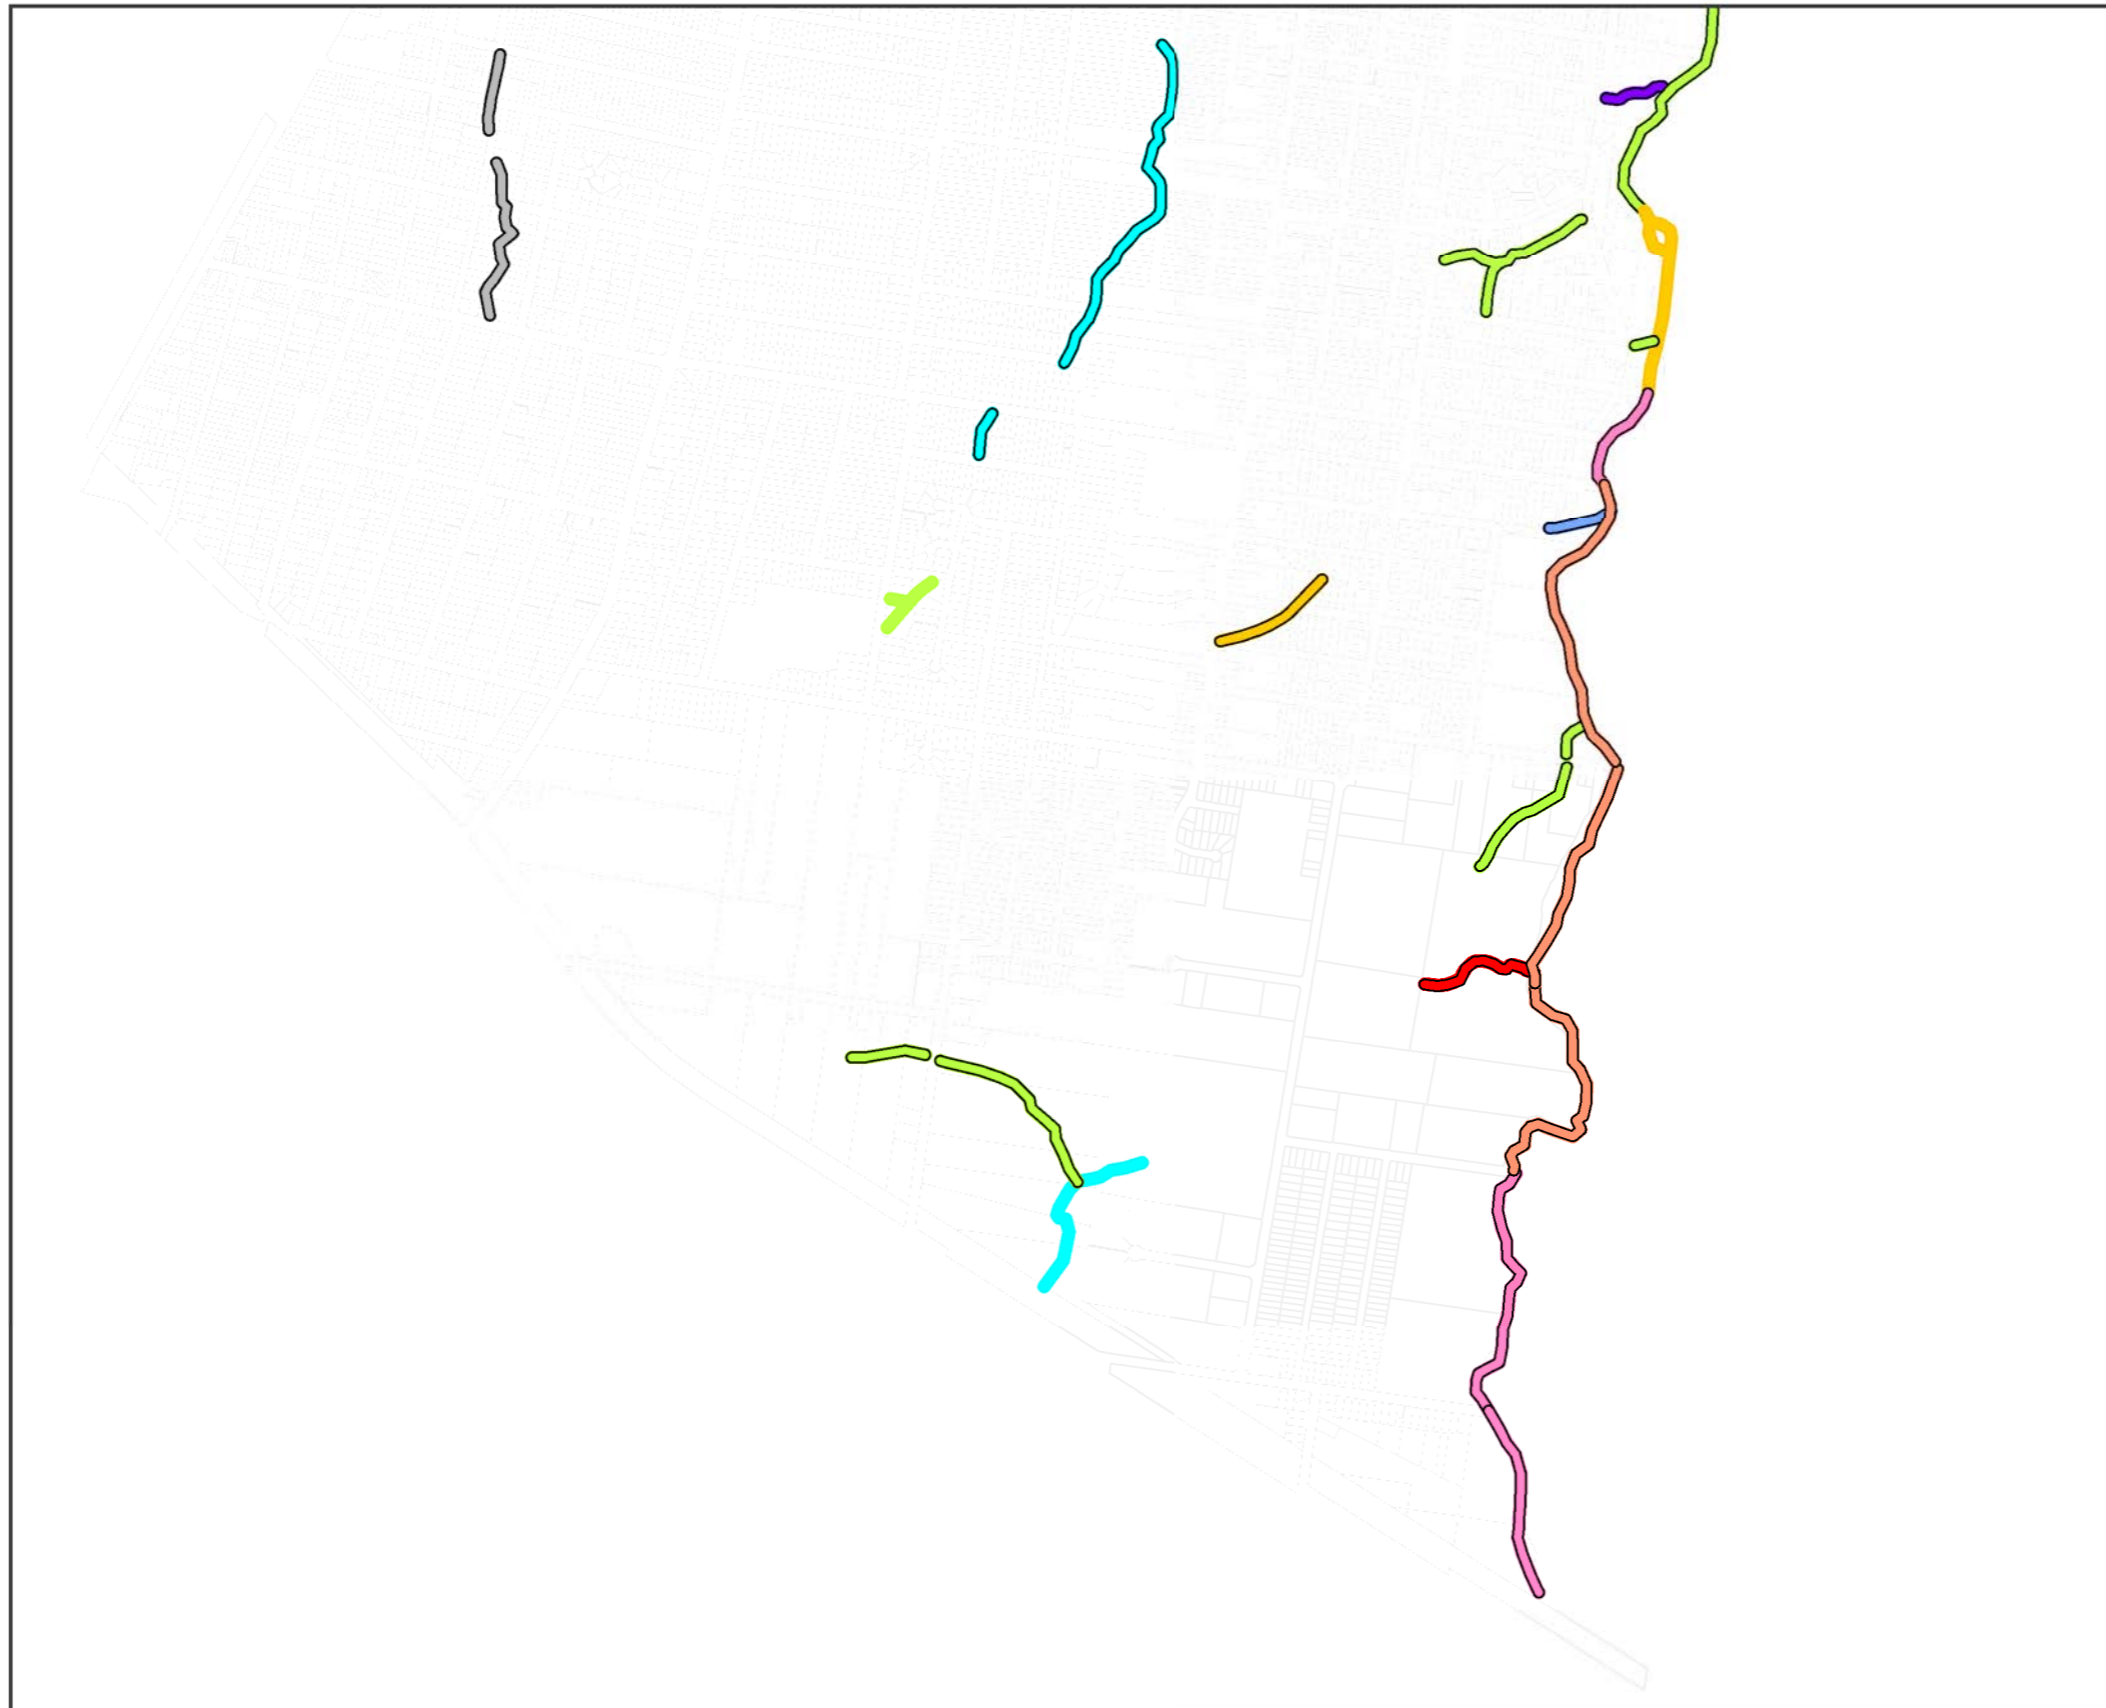
file: attributesMP Map 2
date: 17/05/2012

CHANNEL ATTRIBUTES DUCK RIVER CATCHMENT PARRAMATTA LGA

Concrete lined (managed by Sydney Water)	(10)
Highly eroding	(1)
Moderate/high erosion	(3)
Moderate/Highly Eroding	(1)
Moderately eroding	(3)
Stable	(10)
Stable/ moderately eroding	(3)
Stable/aggregating	(3)
Stable/Moderately eroding	(1)
Tidal/concrete	(1)
Tidal/mangrove/aggregating	(5)

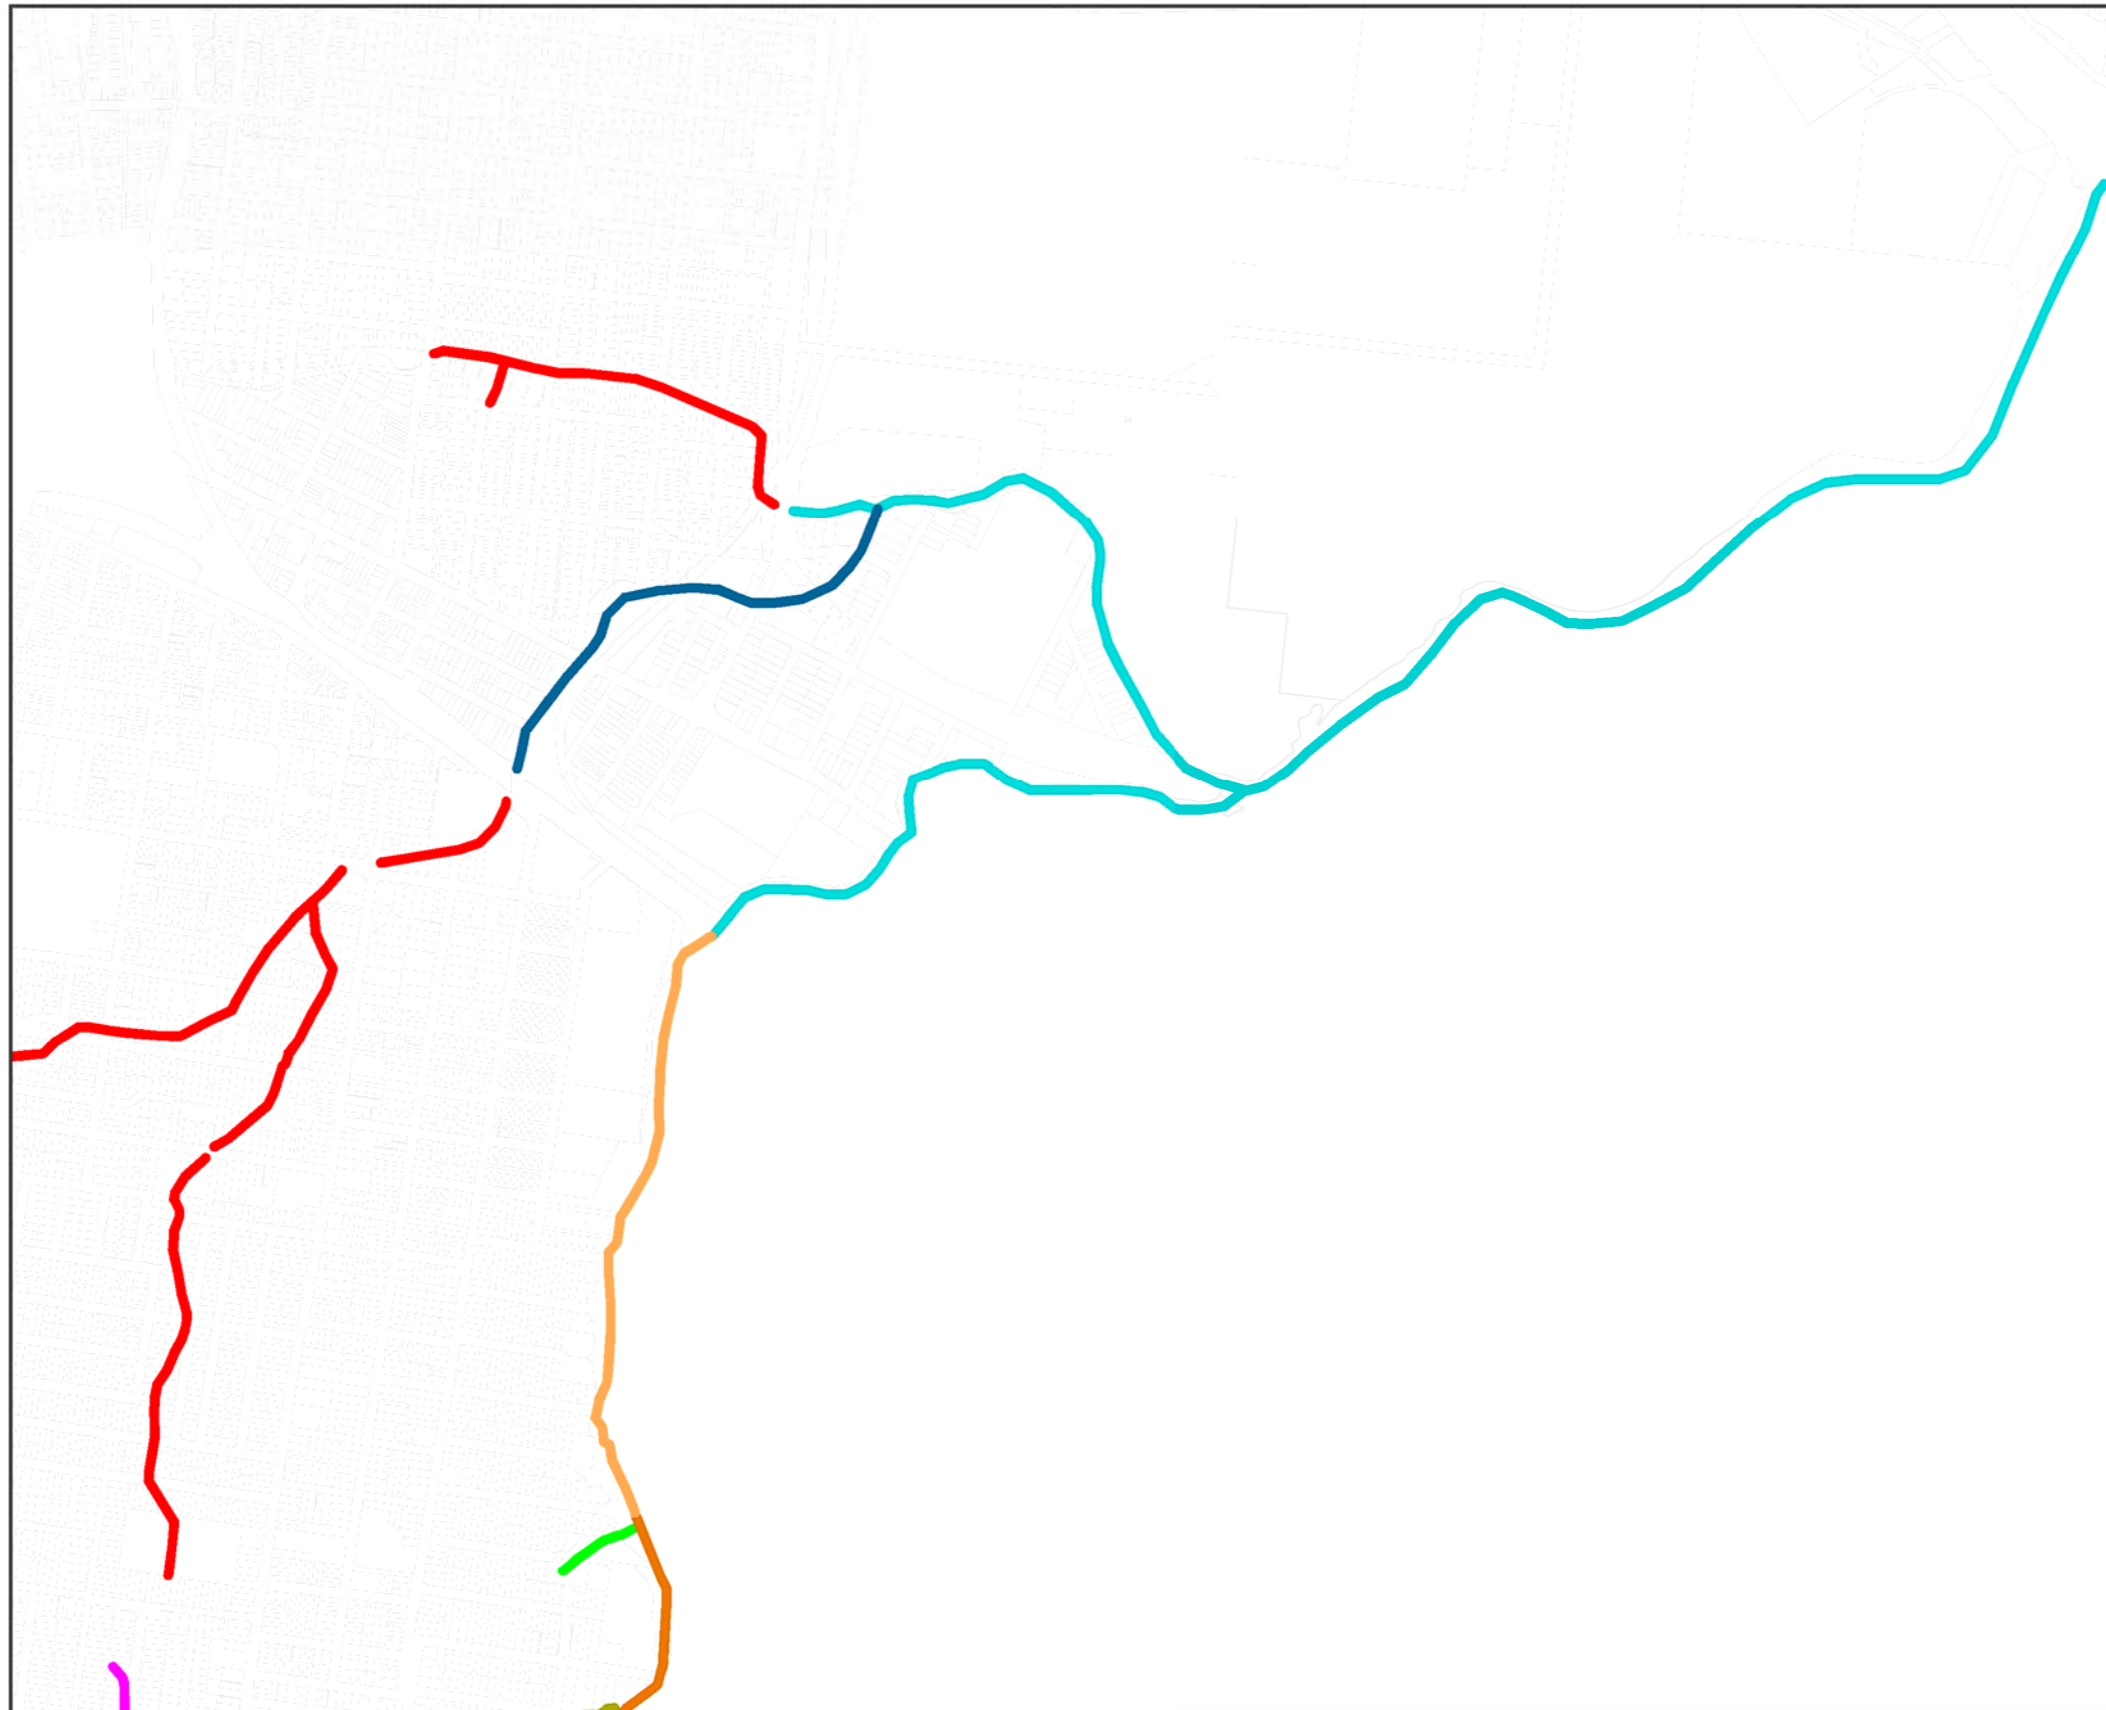
file: processesMP Map 1
date: 17/05/2012

CHANNEL PROCESSES DUCK RIVER CATCHMENT PARRAMATTA LGA

concrete lined	(20)
ephemeral	(12)
pool	(4)
pool/impoundment	(6)
pools/pinch/vegetated	(2)
pools/pinches	(2)
riffles/glide	(4)
riffles/pools	(10)
riffles/pools/pinches	(2)
tidal	(10)
tidal/concrete	(2)
vegetated	(2)
vegetated/ephemeral	(6)

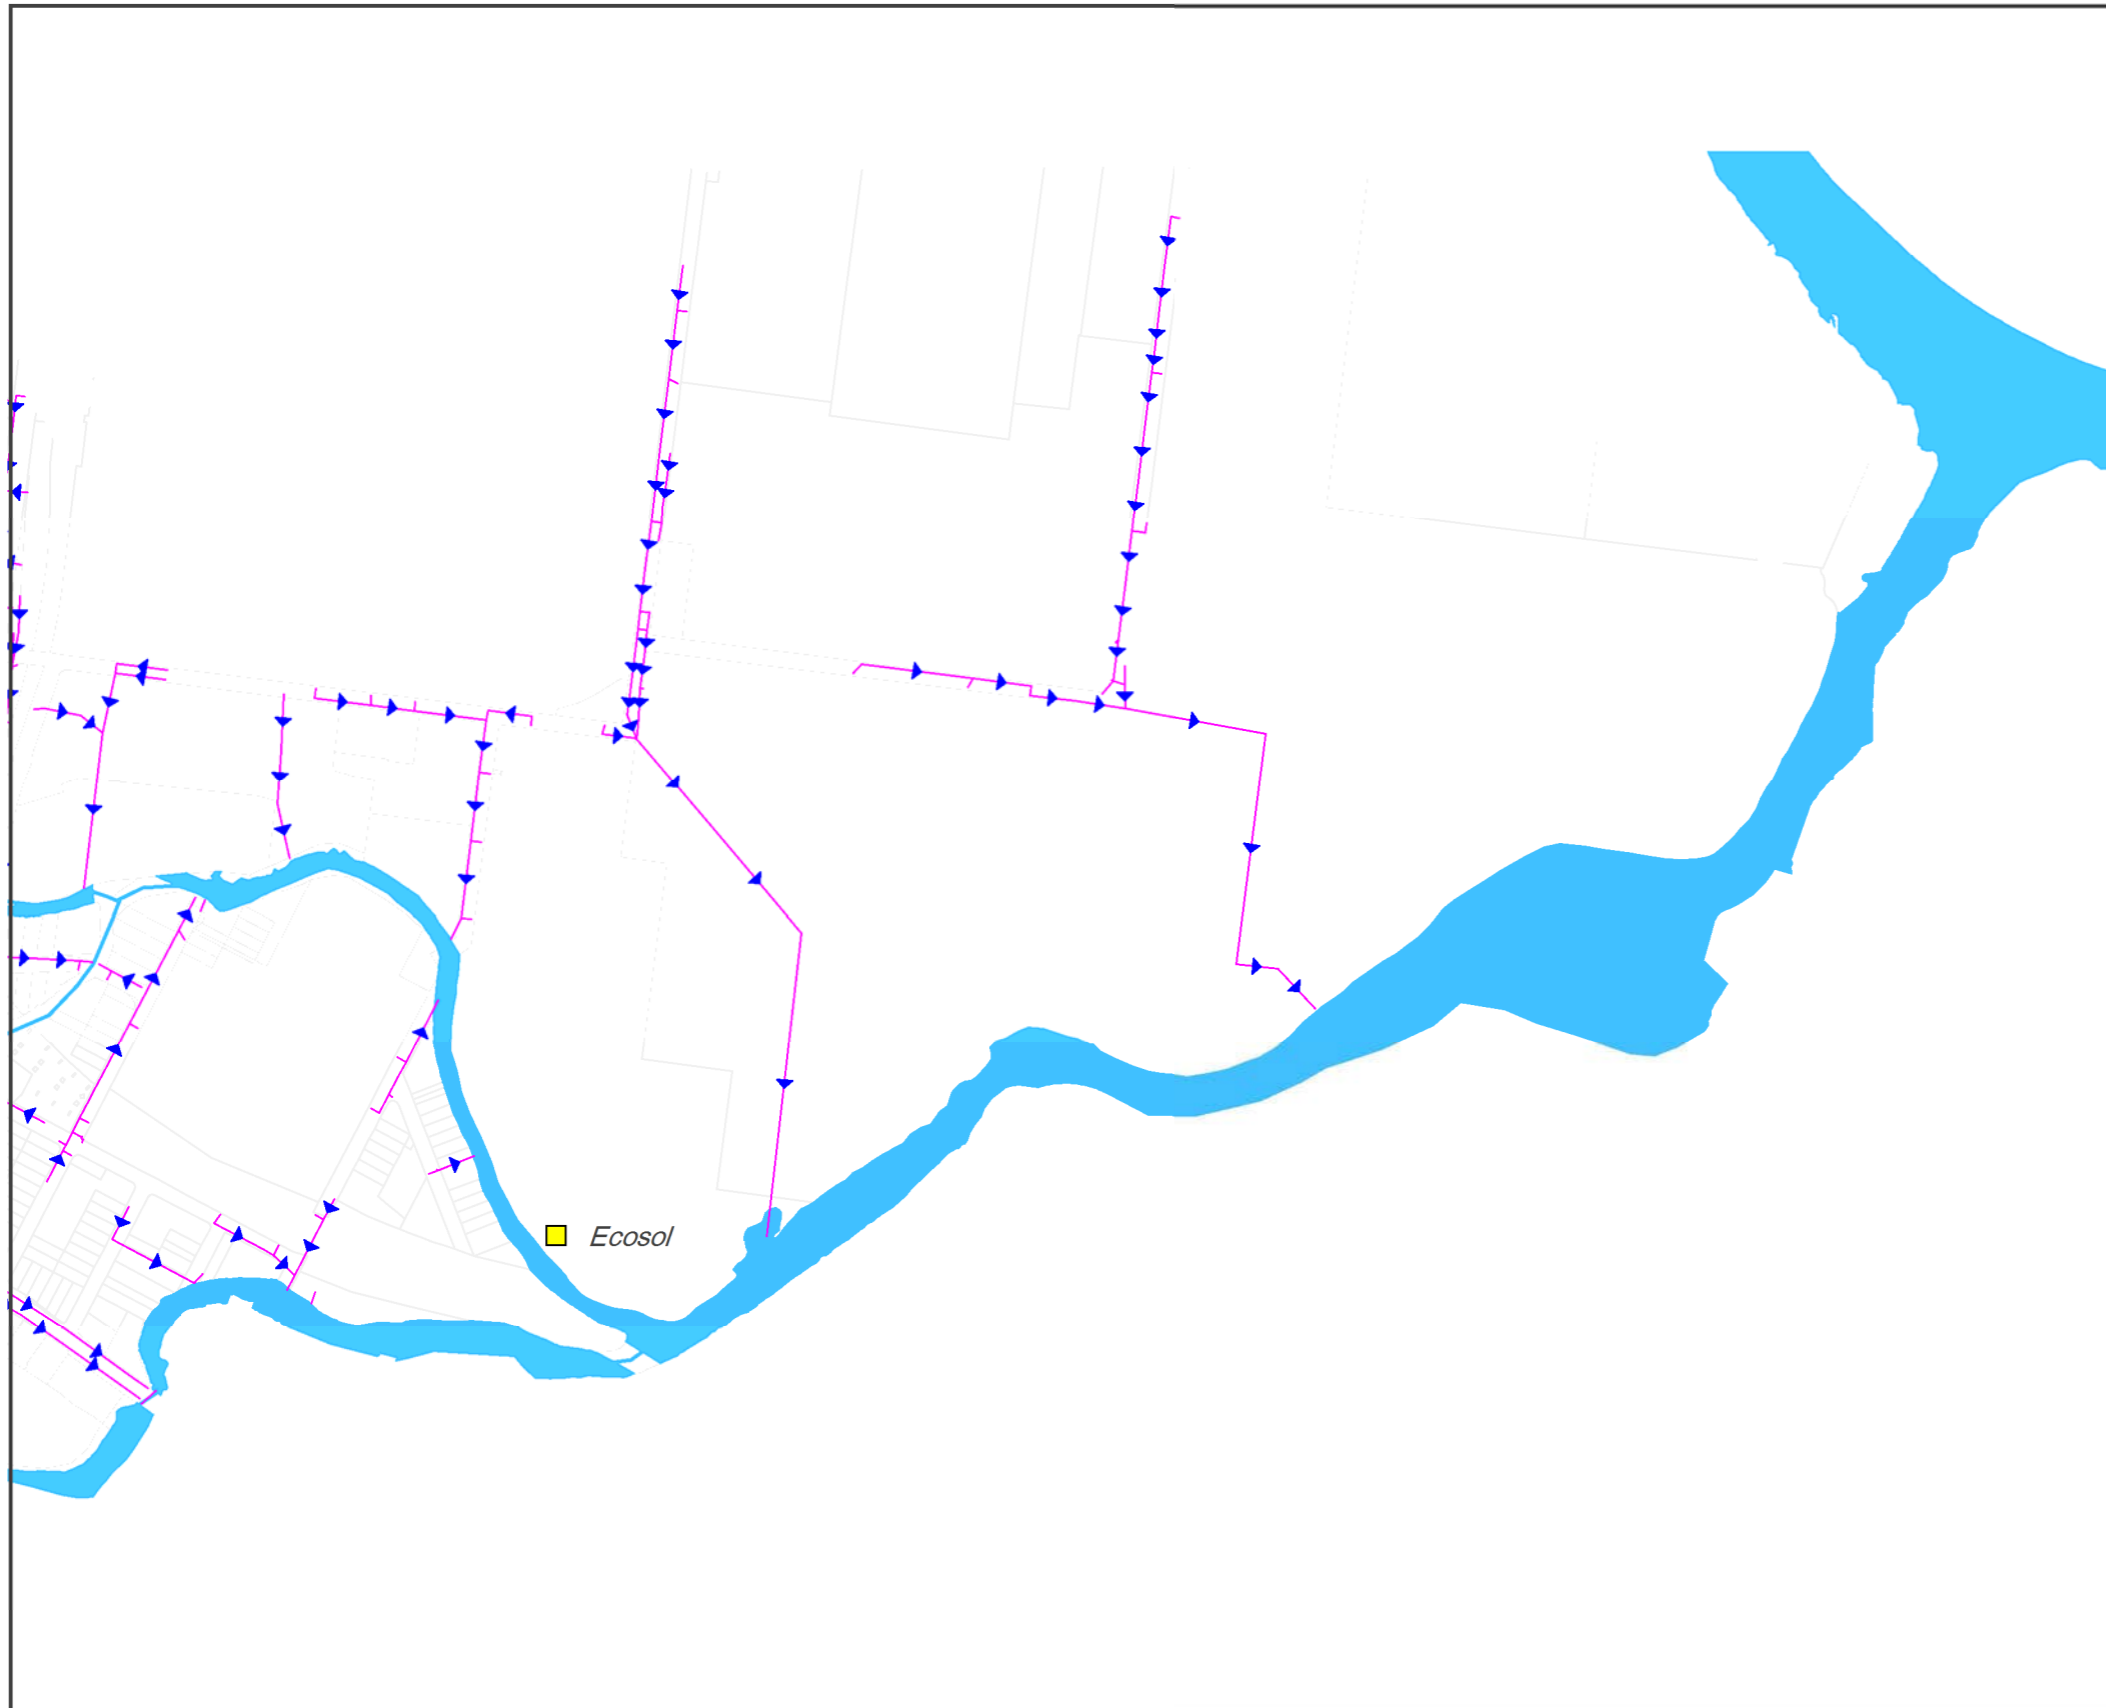
file: SQIDMP Map 1
date: 14/05/2012

PIPE NETWORK, GPTS AND WEIRS - DUCK RIVER CATCHMENT PARRAMATTA LGA

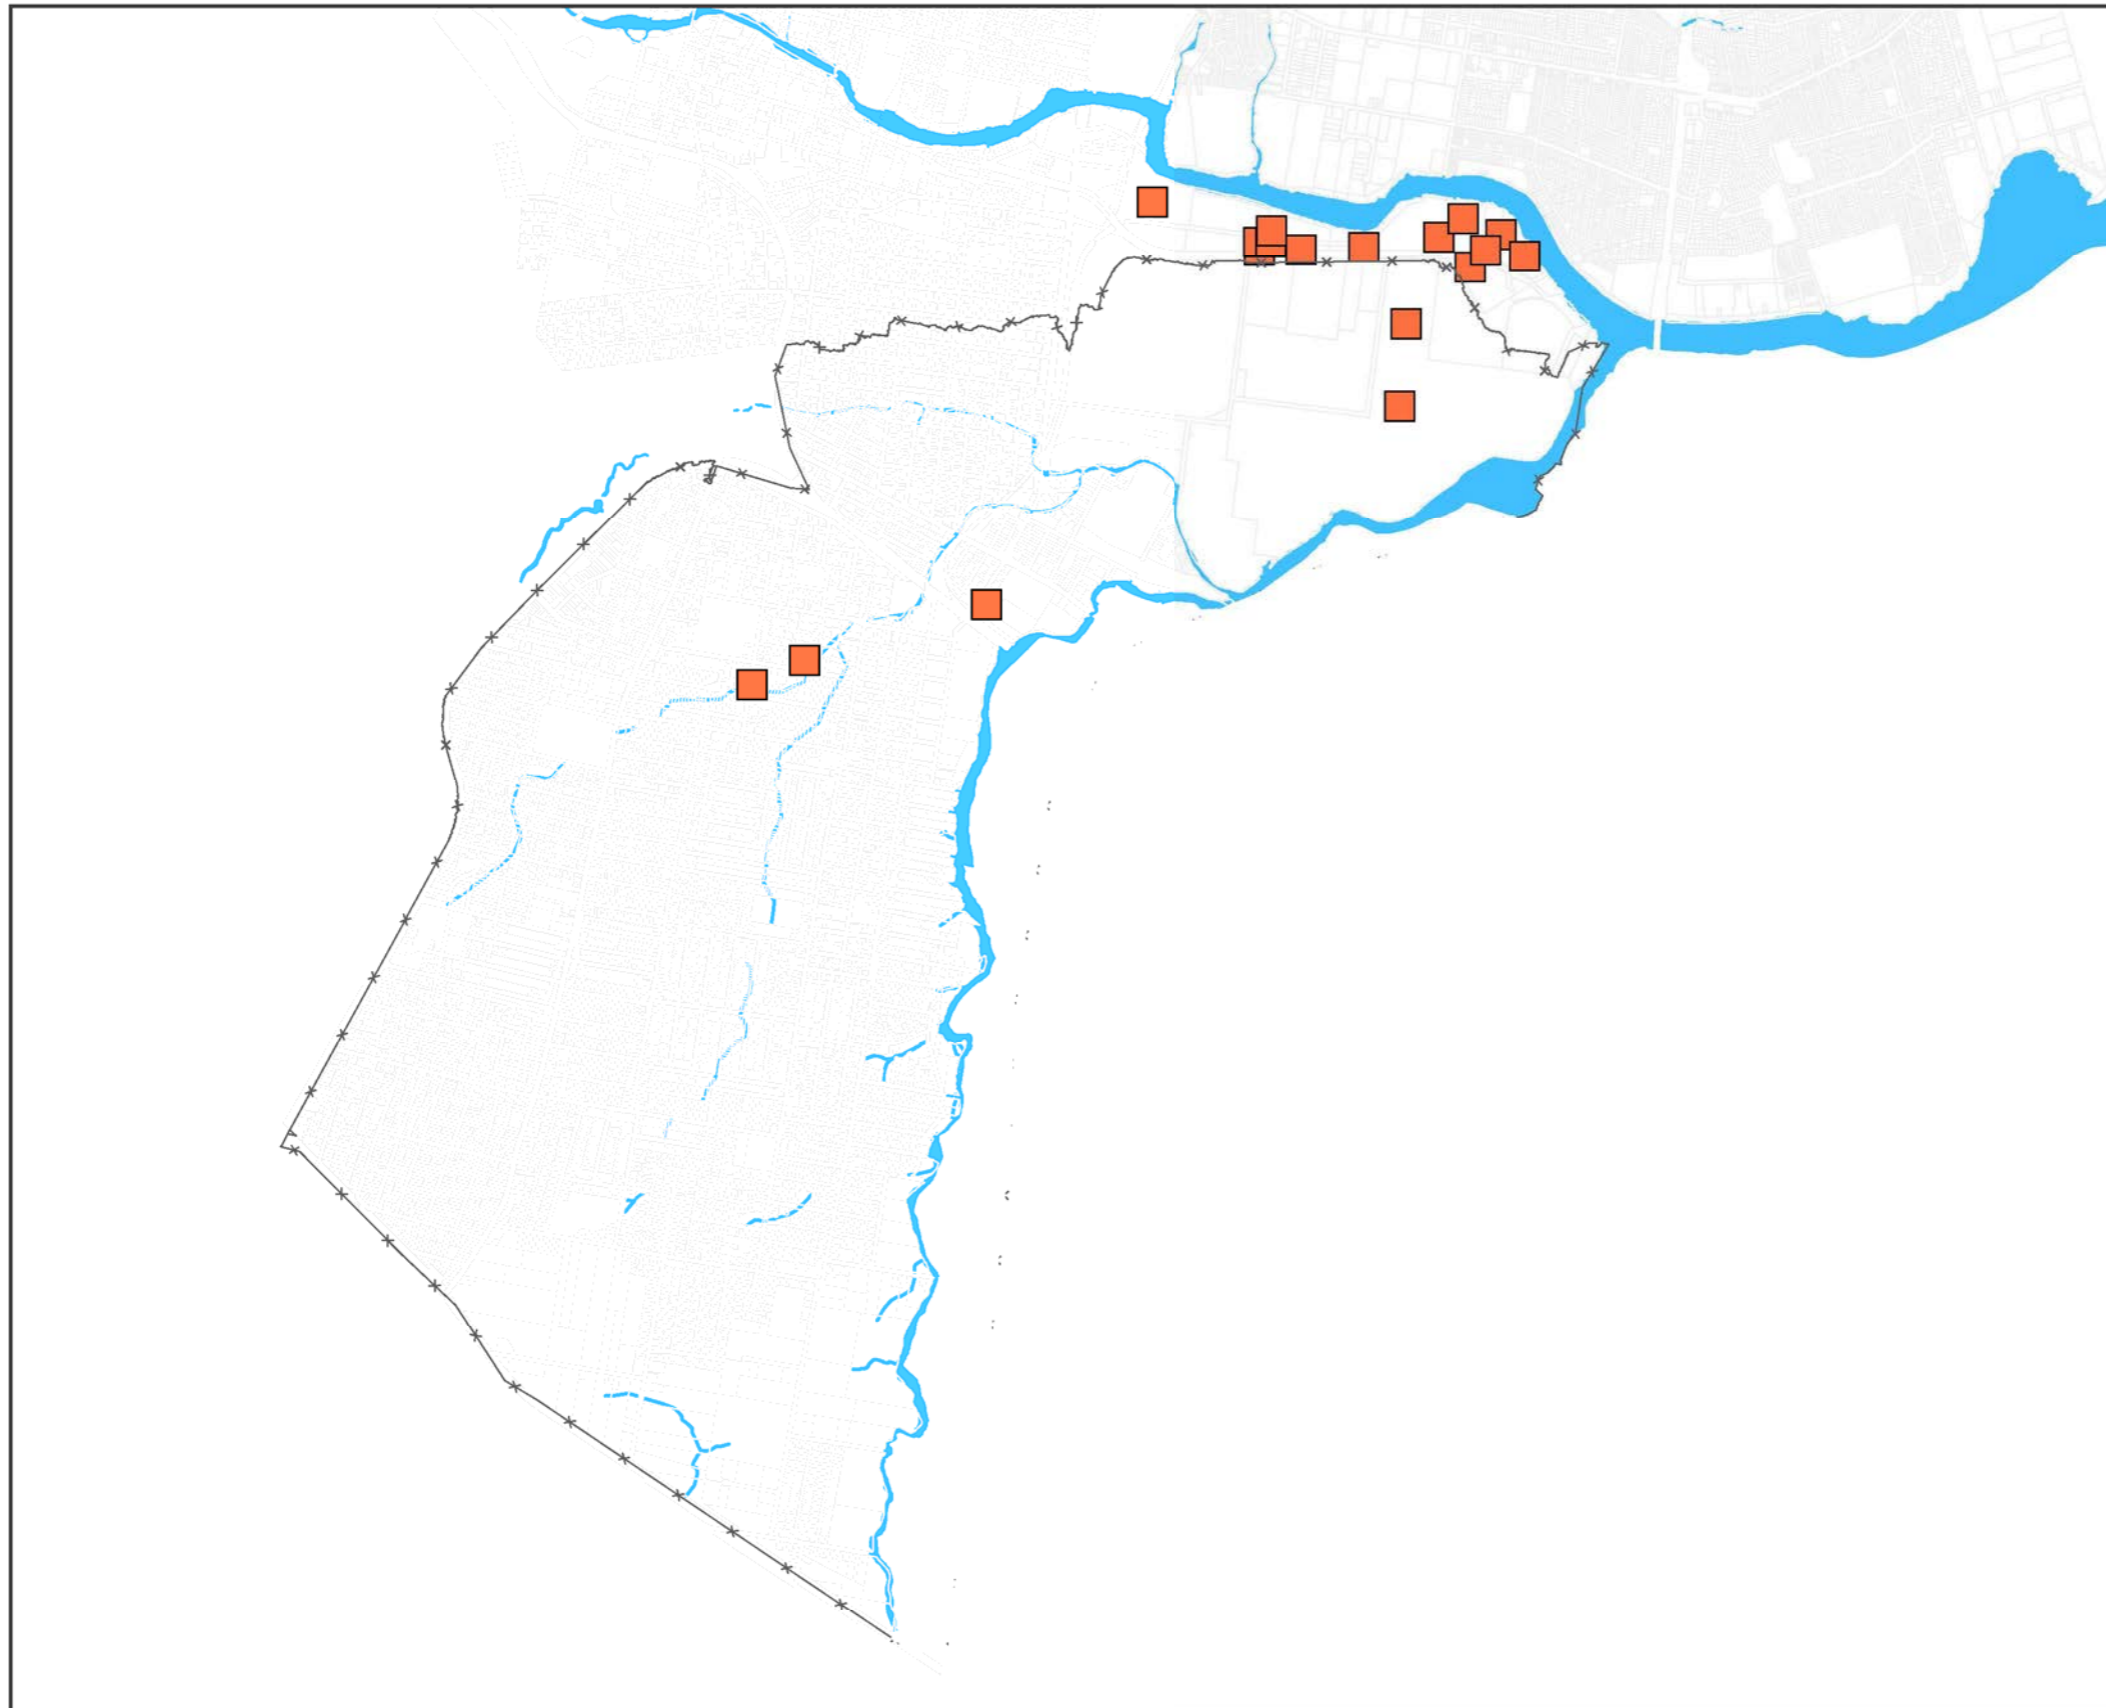
file: Contaminated_Lands
date: 13/05/2012

CONTAMINATED SITES DUCK RIVER CATCHMENT PARRAMATTA LGA
